NCAT Report 89-01

WATER DAMAGE TO ASPHALT OVERLAYS: CASE HISTORIES

This paper presents three case histories of water damage to asphalt overlays over portland cement concrete (PCC) pavements during the last ten years in Pennsylvania. The most recent case of water damage was observed in the summer of 1986 on Interstate 80. Since similar damage had been observed (and documented) on Pennsylvania Turnpike (both East-West and North-East Sections) in the summer of 1978 it was considered prudent to include those unreported ten year old case histories in this paper as well. Data on existing moisture contents in the wearing, binder and leveling courses which is generally not found in the literature, has also been presented. It should be noted that stripping has not been identified as a major problem in Pennsylvania. It has occurred in very few cases such as, these three case histories where excessive water and/or moisture vapor was apparently present in the pavement system. Unfortunately, the subgrade or subbase underneath the PCC pavements constructed in the past are generally highly impermeable to water. These pavements when overlaid with asphalt overlays present a persistent problem due

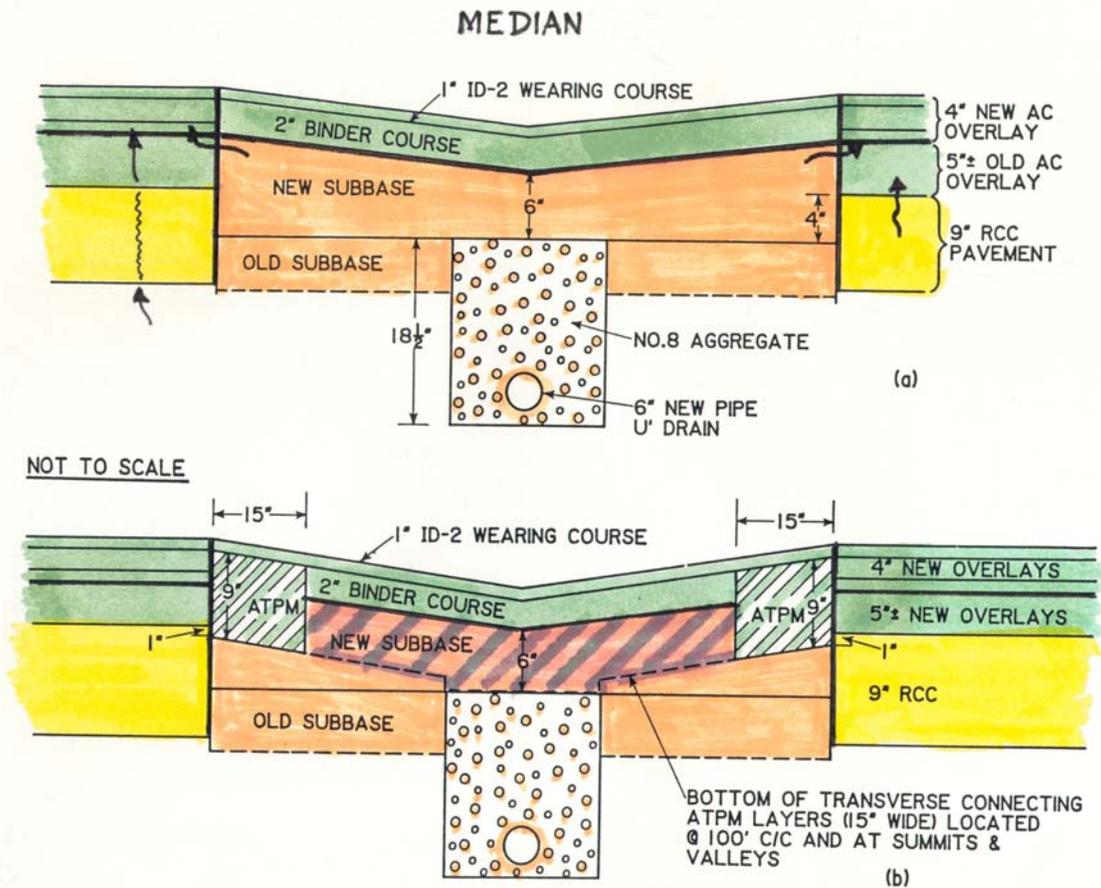
Figure 1. East-West Turnpike Typical Median Section - (a) Existing, (b) Proposed

Visual observations (Tables 1 and 2) indicate that the pavement layers were getting water and water vapor from the subbase in the median (Figure 1a) and from the cracks and joints in the deteriorated concrete. This mechanism will be discussed in detail later.

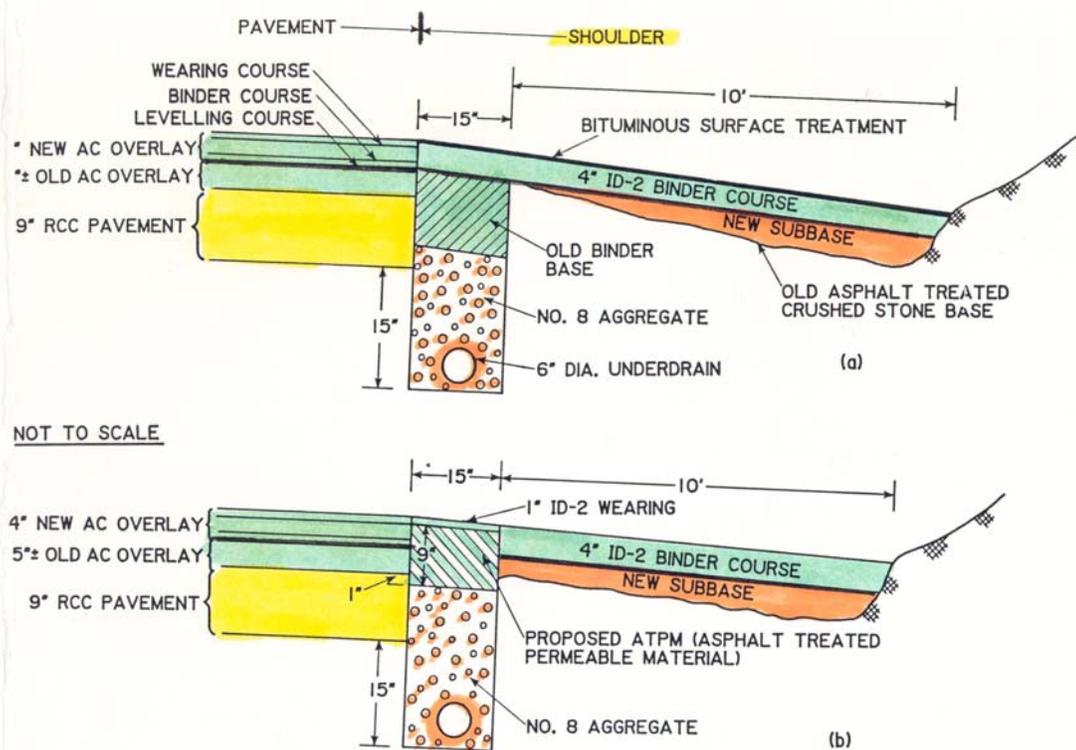
Figure 2. East-West Turnpike Typical Cut Section - (a) Existing, (b) Proposed

¹ Drainage of pavement layers blocked at the pavement edge by the binder course in the shoulder (Figure 2a). No. 8 stone was wet below the bottom line of PC pavement, whereas, dry to damp above this line.

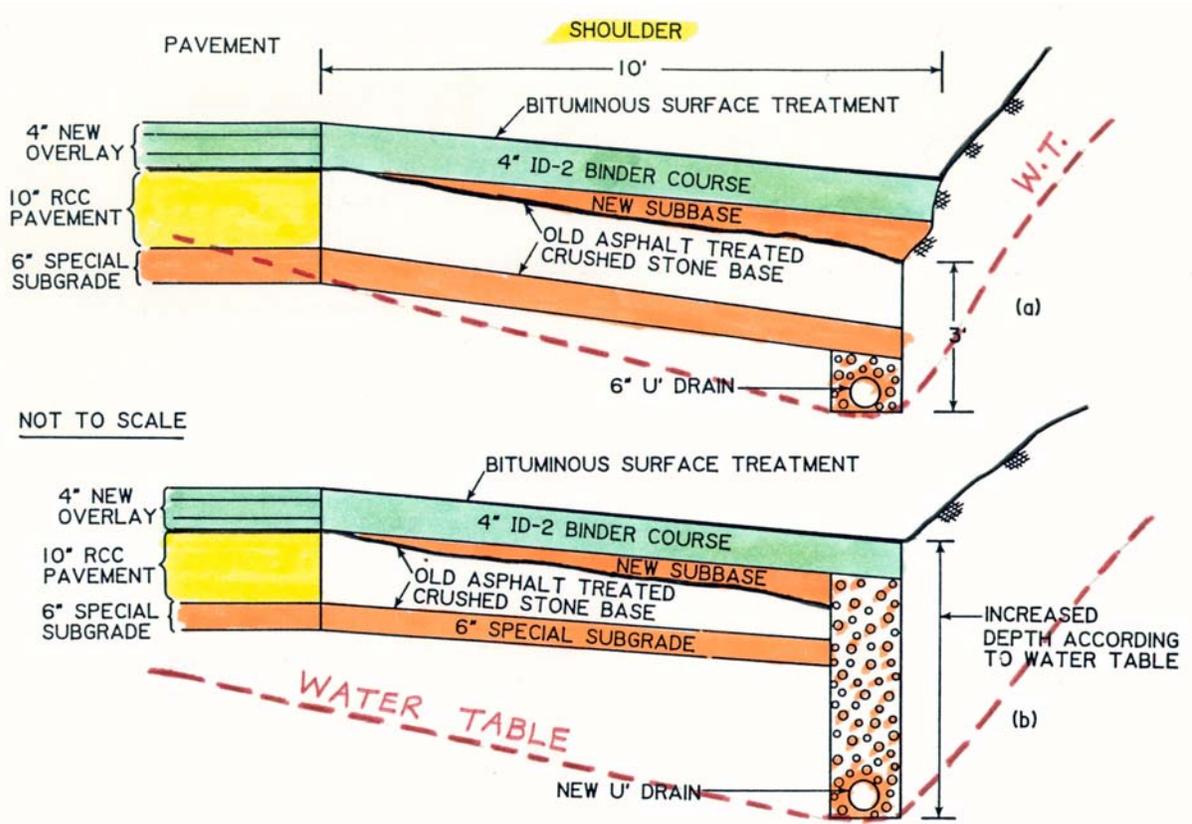
Figure 16. North-East Turnpike Typical Cut Section - (a) Existing, (b) Proposed

Tables 3 and 4 give the visual assessment of moisture and stripping, and laboratory determined moisture contents of the pavement layers. From the appearance of the surface marked with clusters of white spots and no potholes, it did not seem likely that the pavement layers were saturated with water. However, when holes were made by jack hammering, all layers (consisting of 1" wearing course, 2" binder course and 1" levelling courses) were found to be wet. The wearing course had started to strip from the bottom upwards, and severe stripping of the binder course was observed. The concrete was wet and deteriorated at places. The pavement layers were found to be wetter near the concrete median (Figure 18) compared to the area near the center line (Figure 19) in cut areas. Evidently, the new U-drain installed at the toe of the cut slope (Figure 16a) was not deep enough to substantially lower the water table in the vicinity of the median.

Water and/or water vapor was entering this pavement structural system also from underneath through the longitudinal and transverse joints, cracks and disintegrated portions of the PCC pavement. Since the two longitudinal underdrains are only 3 feet deep and are spaced 70 feet apart at the shoulder edges in tangent cut sections; their effectiveness in lowering the water table (especially in the middle of the roadway) and draining the subgrade is questionable (Figure 16). This lack of effectiveness was confirmed by observations in cut areas where the pavement layers were wetter near the concrete median than in the area near the center line. Most of this North-East Extension section is mountainous and is predominantly built in cut sections.

The subsurface drainage should be improved by increasing the depth of the two longitudinal underdrains at the shoulder edge in cut areas. The proposed improvement, as shown in Figure 16b, will also drain the new shoulder subbase, which is sandwiched between two impermeable layers and is causing asphalt stripping in the overlying new binder course.

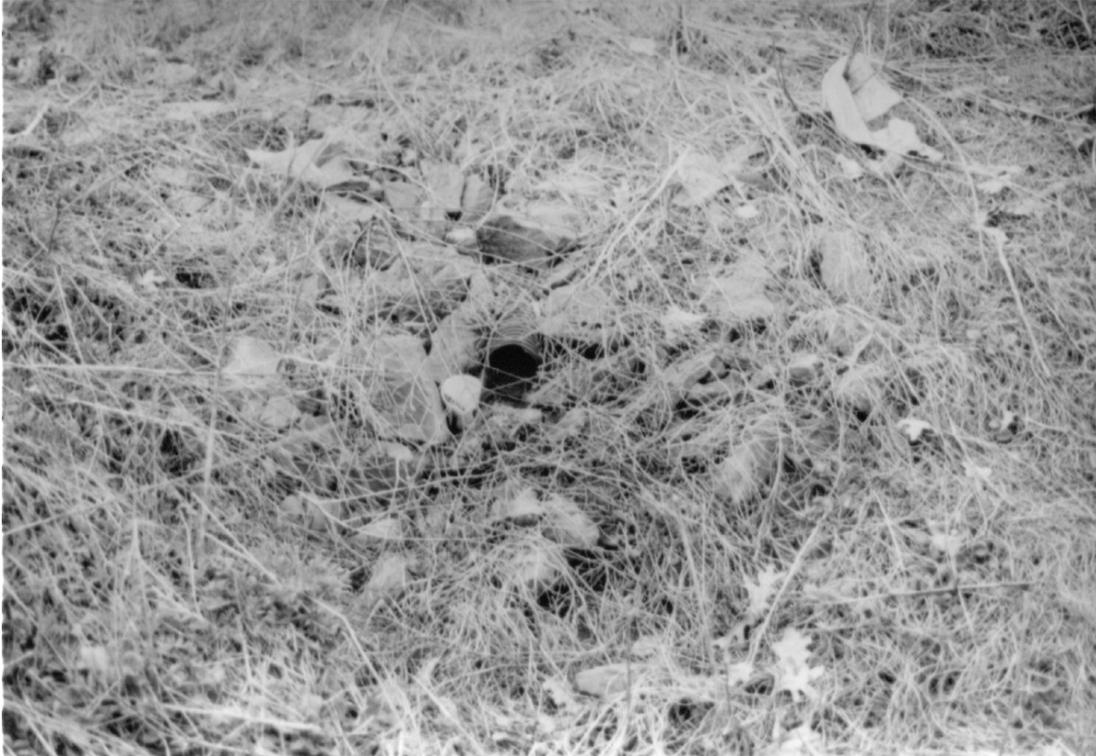
Figure 22. Outlet of the Pavement Edge Drain

It is imperative that the pavement design engineer closely examine drainage related problems of the existing pavement structure especially a PCC pavement when proposing asphalt overlays. Figure 20 shows a PCC pavement with a poorly draining subbase or subgrade. This water is coming out of the transverse joint and being tracked onto the pavement surface by traffic although it had not rained for three days. These localized drainage problems need to be rectified (in some cases transverse drains might be necessary) before the PCC pavement is overlaid for the first time. If the drainage problems are not solved then, a persistent problem of potholing near the transverse joint may haunt the maintenance forces for years, as shown in Figure 21. Periodic maintenance of the existing subsurface drainage system is essential, especially clearing the outlets of pavement edge drains (Figure 22) which can get clogged with debris over the time.
