NCAT Report 91-07

EVALUATION OF PAVEMENT BLEEDING PROBLEM ON I-55 IN ILLINOIS

January 1991

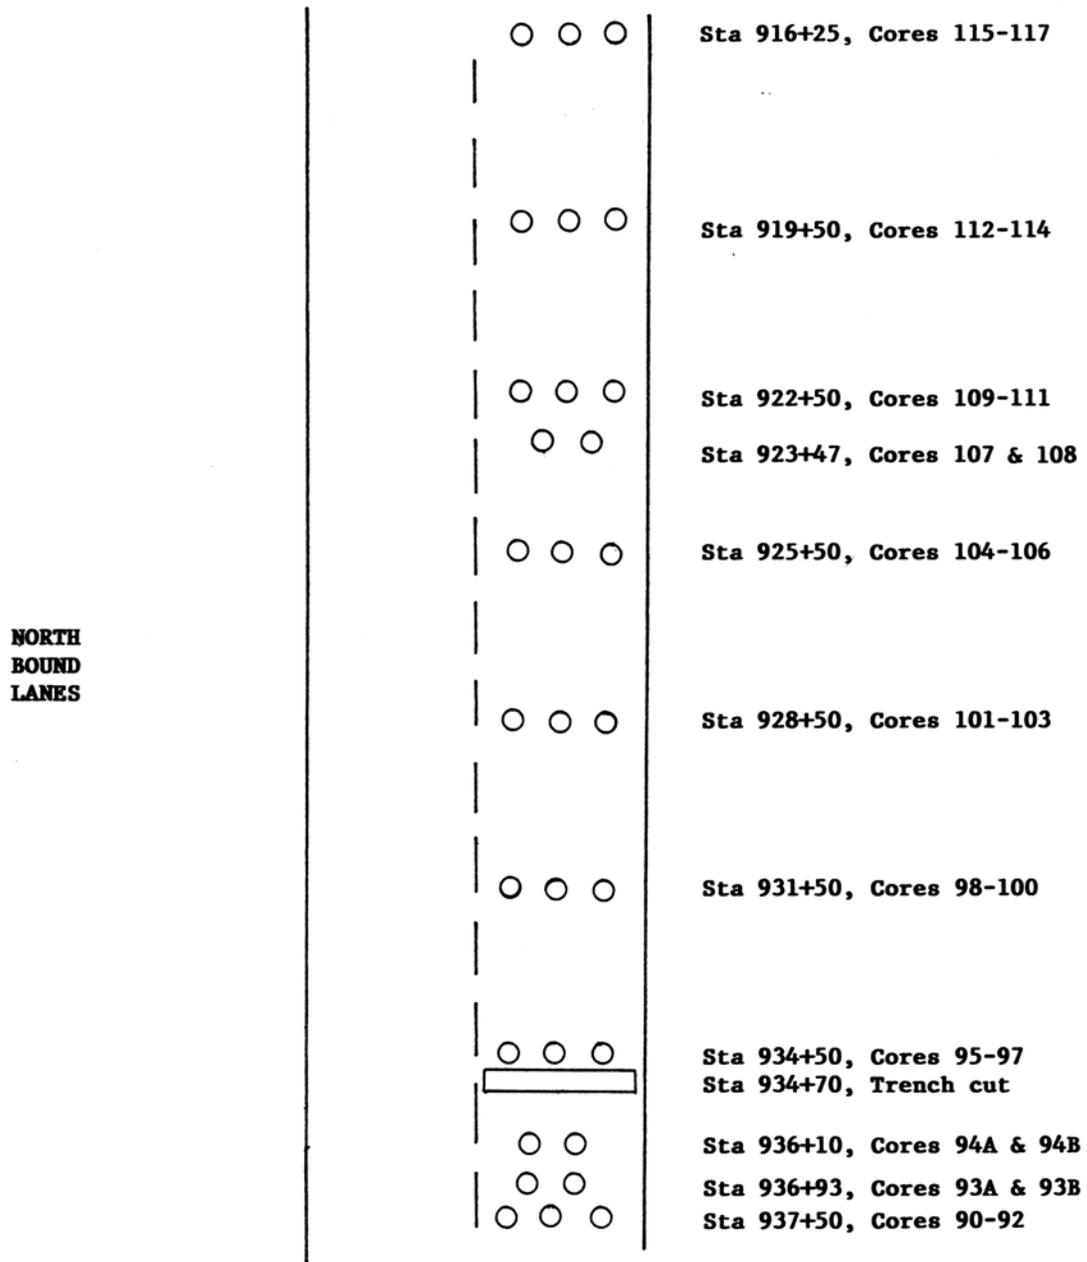
Figure 1. Layout of Test Section North Bound Lanes, I-55, Near Collinsville, IL

A test plan was developed for I-55 to determine the cause of localized bleeding. Samples of asphalt mix were taken in the fat spots, adjacent to the fat spots, and at random from station 916+25 to station 937+50 (Figure 1). A total of 30-4 inch cores were taken for testing. A trench approximately 2 ft. wide and approximately full width was excavated at station 934+70. The trench was selected at a location that had bleeding spots to determine if the problem could be identified by viewing the side of the trench.

Typical cores were taken at 300 ft. intervals to evaluate the average asphalt mix properties. Additional cores were taken in bleeding areas at stations 923+47, 936+10, and 936+93. One core was taken inside the bleeding area and one core was taken immediately adjacent to the bleeding area. The asphalt content and aggregate gradation of the samples in the bleeding areas were compared to that from adjacent areas and to that from the typical cores.
