# A state-of-the-art review on fatigue performance of powder bed fusion-built alloy 718

Additive manufacturing  
Powder bed fusion  
Microstructural characteristics  
Fatigue and fracture  
Alloy 718

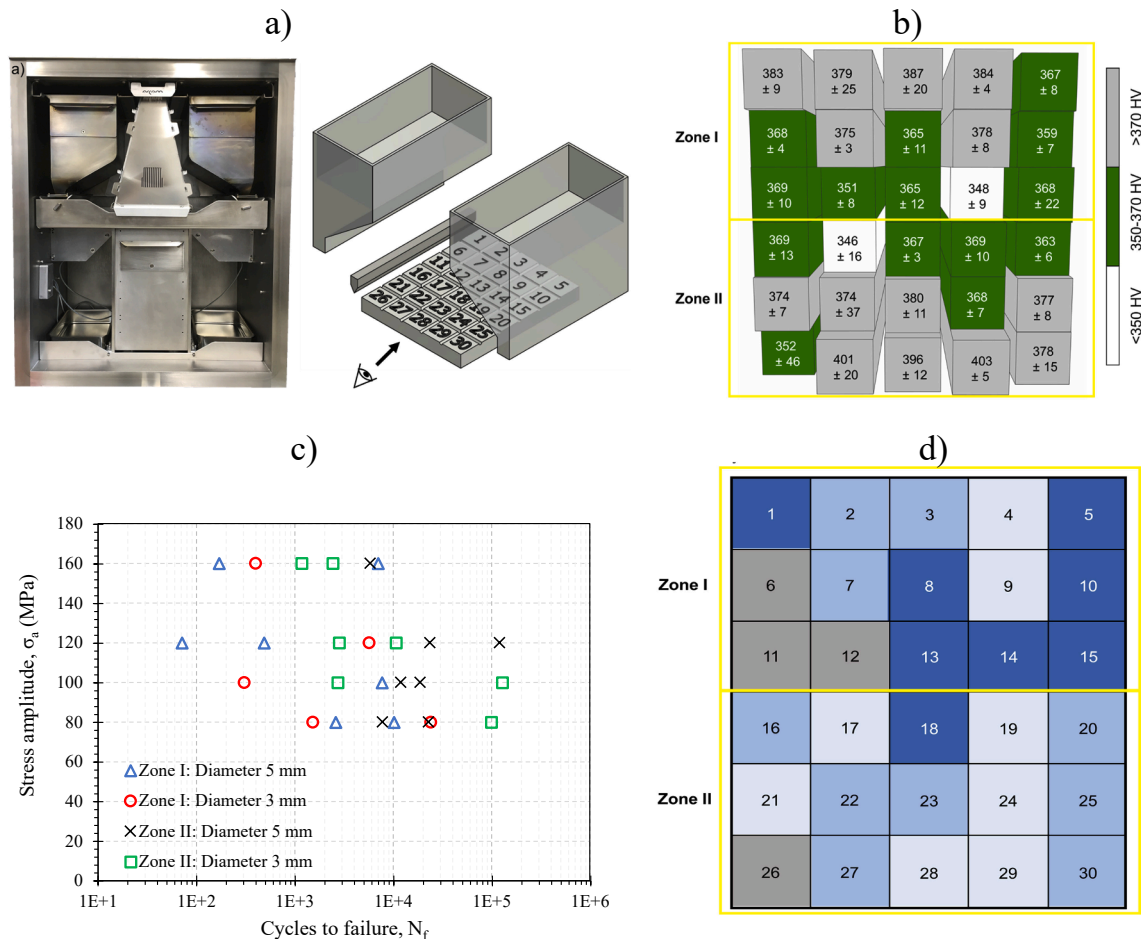
Fig. 6. A) Arcam a2x machine and schematic view of segmentation of the build platform, b) the link between the hardness values and the positions on the building platform, c) stress–cycles to failure curves, and d) color map showing the fatigue performance (dark blue: lowest  $n_f$ , light blue: highest  $N_f$ ) [101]. Reprinted with permission from Elsevier. (For interpretation of the references to color in this figure legend, the reader is referred to the web version of this article.)

The effect of build layout on fatigue performance of EB-PBF of Alloy 718 was investigated [101]; see Fig. 6. The influence of the part location on the microstructure was insignificant; therefore, the microstructure evolution was excluded from the observed scatter in the fatigue results related to the part location. The building layout affected the surface topography and, consequently, fatigue life. The parts in the front half of the build plate (zone II) showed superior LCF life. Meanwhile, the parts built at the outer regions of the build plate showed high hardness values; however, a closer look at the hardness values confirmed that only two samples (colored in white) had very low hardness values. Therefore, it can be indicated that the building layout did not have a significant effect on hardness. The

plate-pile-like stacking surface features observed on the as-built samples were found extremely deleterious in fatigue. The location of the parts did not notably influence the relative density of the parts on the build platform. Therefore, the pores were resulted from the individual non-uniformities within distinct part volumes during EB-PBF.

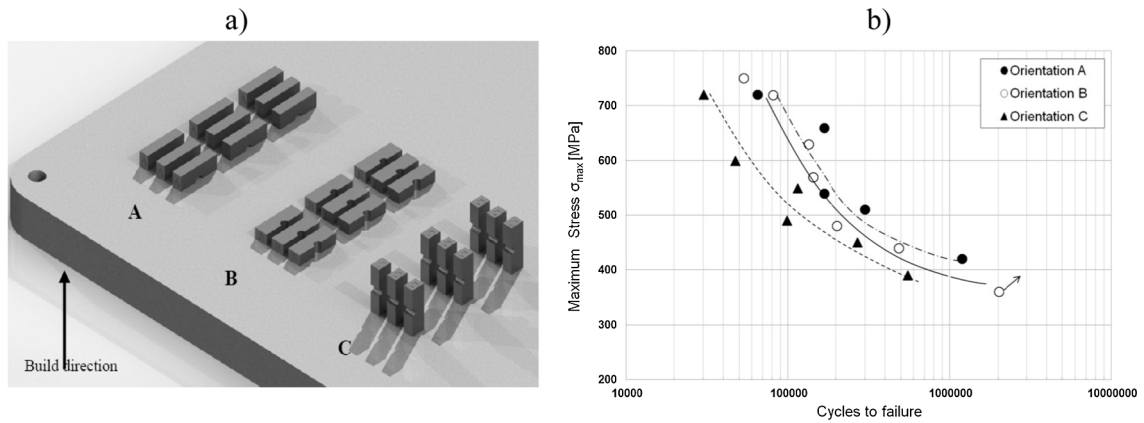
**Fig. 13.** A) Rendering of specimens layout in the build, and b) fatigue life of lb-pbf-built alloy 718 in different orientations with respect to the build orientation [147]. Reprinted with permission from Elsevier.

The HCF life of LB-PBF-built Alloy 718 was investigated via a novel test method to quantify the anisotropic fatigue performance [147]. The level of anisotropy of LB-PBF-built Alloy 718 was studied by testing the parts manufactured in three different directions (A, B, and C); see Fig. 13. The S–N curves showed that the direction parallel to the build direction had the minimum fatigue strength. The directionality of HCF showed that applying the cyclic loading in the build direction (C) was the most dangerous loading direction for the part, resulting in the shortest fatigue life. The other part orientations (A and B) exhibited identical fatigue life. The anisotropic fatigue performance is due to the complex microstructure inherently obtained by the layer-by-layer manufacturing process. In general, the directional fatigue response was due to i) the surface roughness that was different in the three different directions (A, B, and C), and ii) the crack initiation mechanisms.

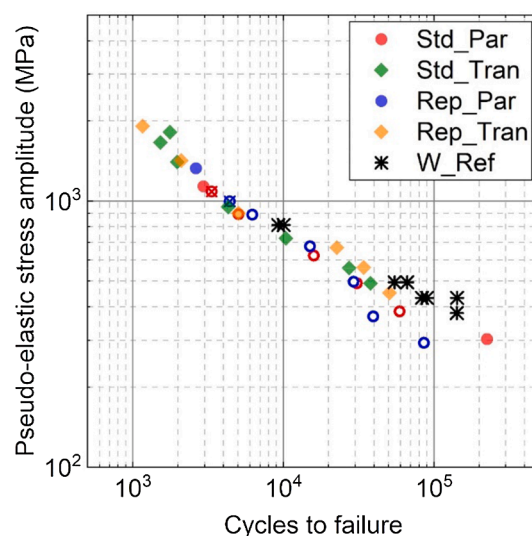
**Fig. 14.** Pseudo-elastic stress amplitude vs fatigue life plot. Par, Tran, Std, Rep, and W represent parallel direction, transverse direction, standard heat treatment, repair heat treatment, and wrought Alloy 718. Open symbols indicate inclusion-based crack initiation, and solid symbols indicate crack initiation due to slip at the specimen surface [149]. Reprinted with permission from Elsevier.

parallel direction than the transverse direction because the elastic modulus ( $E$ ) was lower in the former direction [149]. It was postulated that the resolved shear stress on the slip planes in part loaded in the parallel direction was lower than the transverse direction. The pseudo-elastic stress based on the strain amplitude and elastic modulus ( $\sigma_{\text{pseudo-elastic}} = \epsilon_a E$ ) versus fatigue life was drawn; see Fig. 14. After implementing the pseudo-elastic characteristics, the points for the parallel and transverse directions, in different post-treatment conditions (Std and Rep represent standard and repair heat treatment, respectively), converged to a linear behavior. Moreover, the scatter in data was associated with the presence of the surface inclusions.

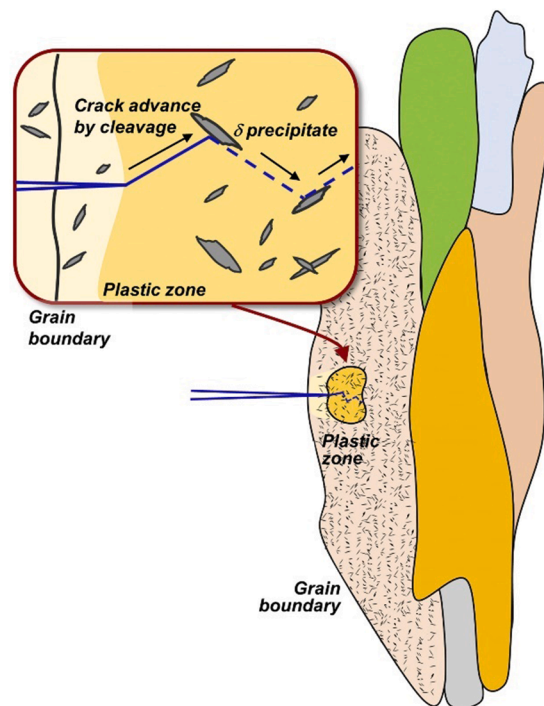
**Fig. 16.** The schematic view of the interaction between  $\delta$  precipitates and a growing crack following a particular cleavage plane, demonstrating how precipitates and/or Laves phases frequently obstruct the advancement of the crack [169].

According to Fig. 16, grain orientation has a negligible effect on the crack propagation of LB-PBF Alloy 718 because  $\delta$  precipitates, rather than grain boundaries, obstruct the advance of growing crack at the crack tip [169]. Indeed, several studies have demonstrated that the relationship between the direction of construction and the direction of crack growth has no effect on the crack propagation resistance of the AM Alloy 718 parts [146]. Previously, fractographic examination of Alloy 718 specimens fabricated using the LB-PBF process revealed that the number of defects on the fracture surface was significantly greater than the number of defects on the microstructure, implying that fatigue cracks tended to grow in the direction of the relatively weak area containing defects [65].

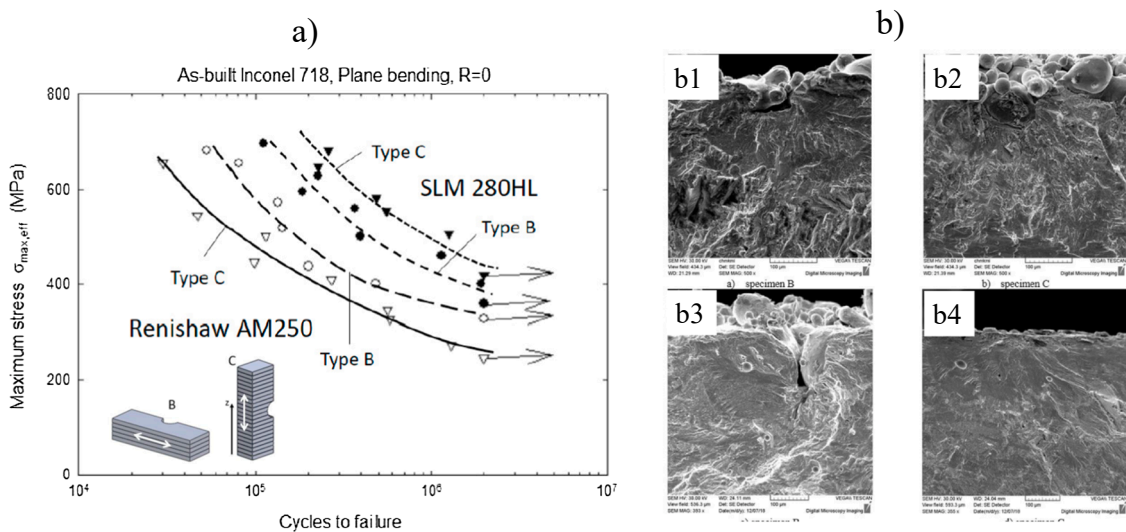
**Fig. 20.** A) Orientations of the miniature specimen with respect to the build direction. The white arrows show the applied stress direction. The fatigue life of Alloy 718 built via two LB-PBF machines, b) crack initiation sites in the parts built via b1), b2) Renishaw AM250, and b3), b4) SLM 280 HL [193]. Reprinted with permission from Elsevier.

The fatigue life of the LB-PBF-built Alloy 718 parts built in two different LB-PBF machines and different loading directions was studied [193]; see Fig. 20. The process parameters and scanning strategy significantly influenced the fatigue performance of Alloy 718. The LB-PBF part built via SLM Solutions 280HL with a 50-μm layer thickness provided a greater fatigue life than the part built via Renishaw AM250 with a 30-μm layer thickness; see Fig. 20c. Thicker layers increased the build rate in the flat surfaces, but thinner

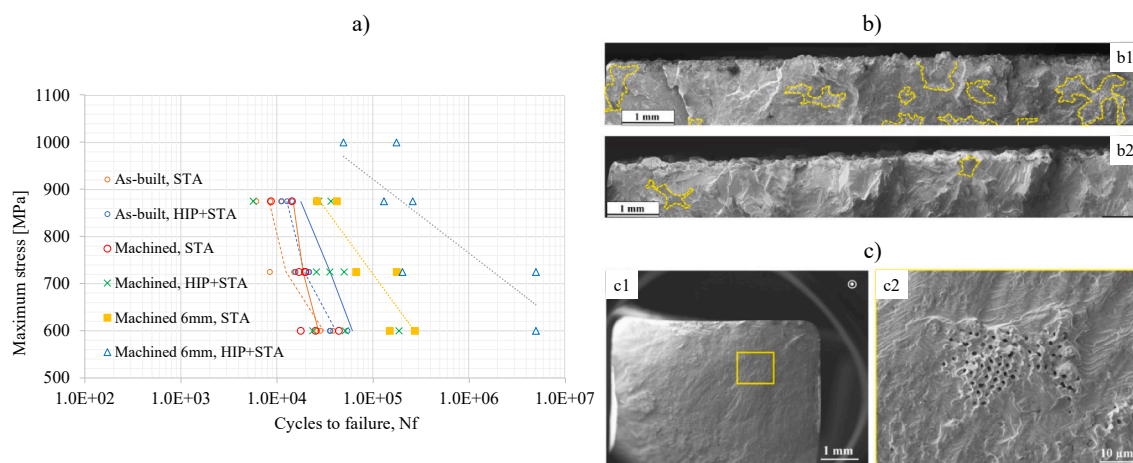
**Fig. 24.** A) S—N curves of EB-PBF-built Alloy 718 in various post-treated conditions, b) SEM images (SE mode) of fracture surfaces presenting the crack initiation sites in the as-built surface condition of the (b1) STA part; (b2) HIP + STA part. The yellow dotted lines show the LoF region, and c) SEM images (SE mode) of the fracture surface of a part in the STA condition; (c1) overall view, (c2) the shrinkage pores in the crack growth region [177]. Reprinted with permission from Elsevier. (For interpretation of the references to color in this figure legend, the reader is referred to the web version of this article.)
