RESEARCH PROJECT TITLE

Evaluation Rock Check Dam Performance using Large-Scale Testing Techniques

Final Report
May 2025

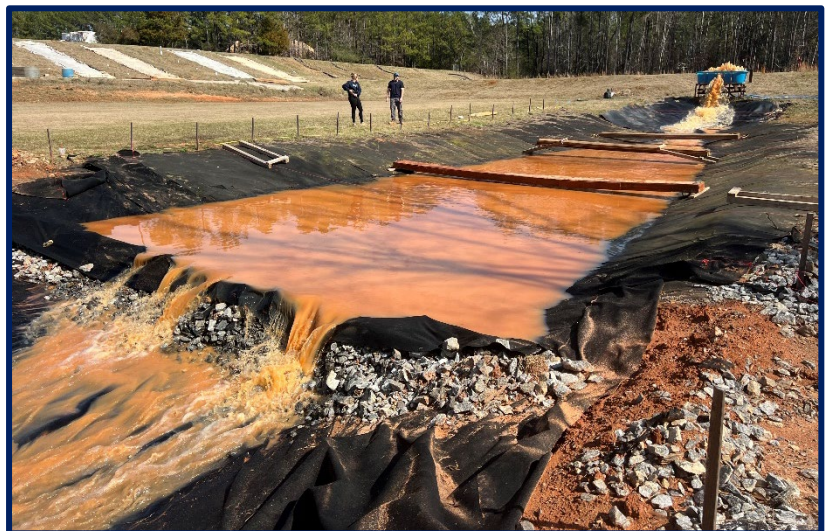
Most Feasible and Effective Installation (MFE-I)

- The Most Feasible and Effective – Installation was determined to be a rock check dam with no excavation, the Iowa DOT erosion stone, a geotextile overlay with dewatering holes, and a reduced width due to outperforming other installations in impoundment formation and reducing the cost of material and installation.
- Adding a geotextile overlay and reducing the size of rock used were found to significantly increase impoundment length and erosion protection compared to the standard installation.

The MFE-I consisted of a combination of modified components (no excavation, smaller rock gradation, and a geotextile overlay with dewatering holes), with a reduced width to further reduce cost of material. This installation had the highest impoundment facilitated, with an average of 58 ft. Additionally, the approximate material cost was reduced by 55% compared to the Iowa DOT standard rock check dam installation. Due to performance improvements in all areas and the reduced cost, this installation was selected as the MFE-I.

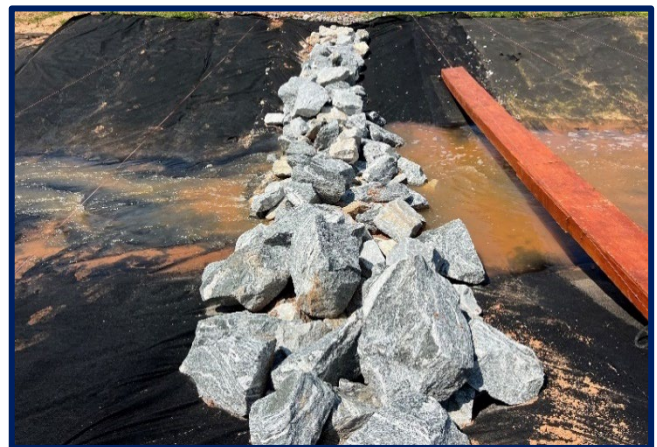
Iowa DOT Standard rock check dam

The Iowa DOT standard rock check dam installation, consisting of Class D Revetment with a 6 in. excavation and a geotextile underlay, was evaluated. The standard installation impounded approximately 6 feet on average, indicating that only 9% of the channel was protected from erosive flow conditions.

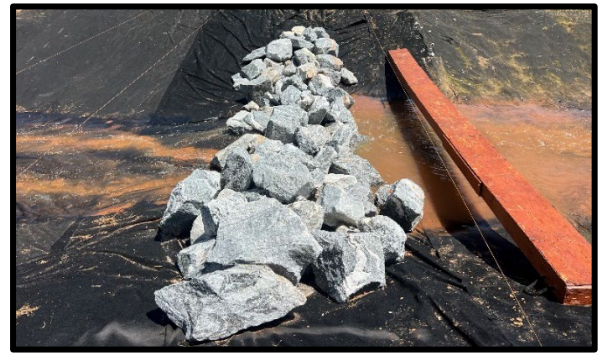
Performance of Installation On Grade

impoundment formation and velocity reduction. No adverse impacts on impoundment length compared to the standard were found after removing the excavation and installing the rock check dam on grade, while also saving cost of material and installation.

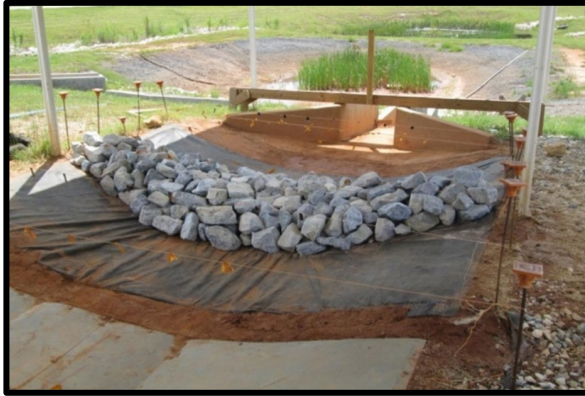
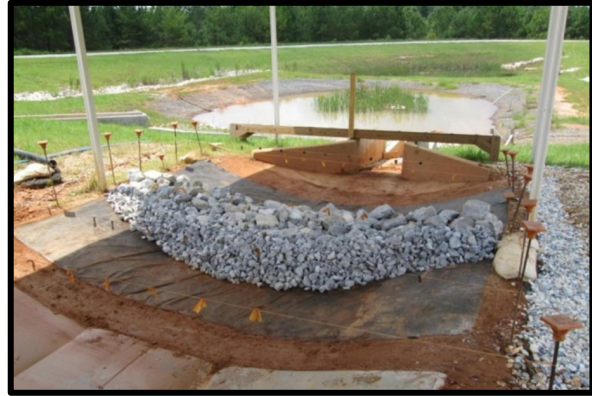
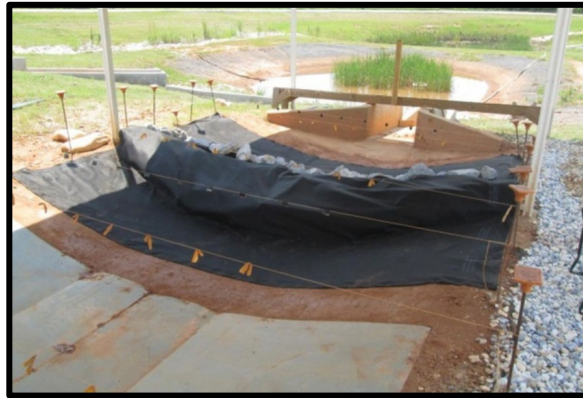
Figure 2.3: Rock Check Dams Evaluated by Zech et al. (2014)

The standard Alabama DOT rock check dam installation, 18 in. (45.7 cm) high over a geotextile underlay, was ineffective at forming impoundment due to high flow-through rates during testing. The standard rock check dam installation facilitated a maximum impoundment length of only 14.5 ft (4.42 m); this resulted in an efficiency of only 48.3%, indicating that more than half of the channel was unprotected from erosion due to highly erosive supercritical flows. Two alternative installations were tested to increase impoundment potential: a choker consisting of No. 4 coarse aggregate on the upstream face of the dam and a geotextile wrapped around the front face of the check dam. Figure 2.3 shows the standard and modified rock check dam tested at the AU-SRF. Both modifications increased impoundment, with the choker stone increasing impoundment to 20.5 ft and increasing efficiency to 68% and the geotextile choker doubling impoundment to 29.1 ft (8.9 m) and increasing efficiency to 97.0% (Zech *et al.* 2014).

(a) Alabama DOT standard rock check dam

(b) rock check dam with aggregate choker

(c) rock check dam with geotextile overlay

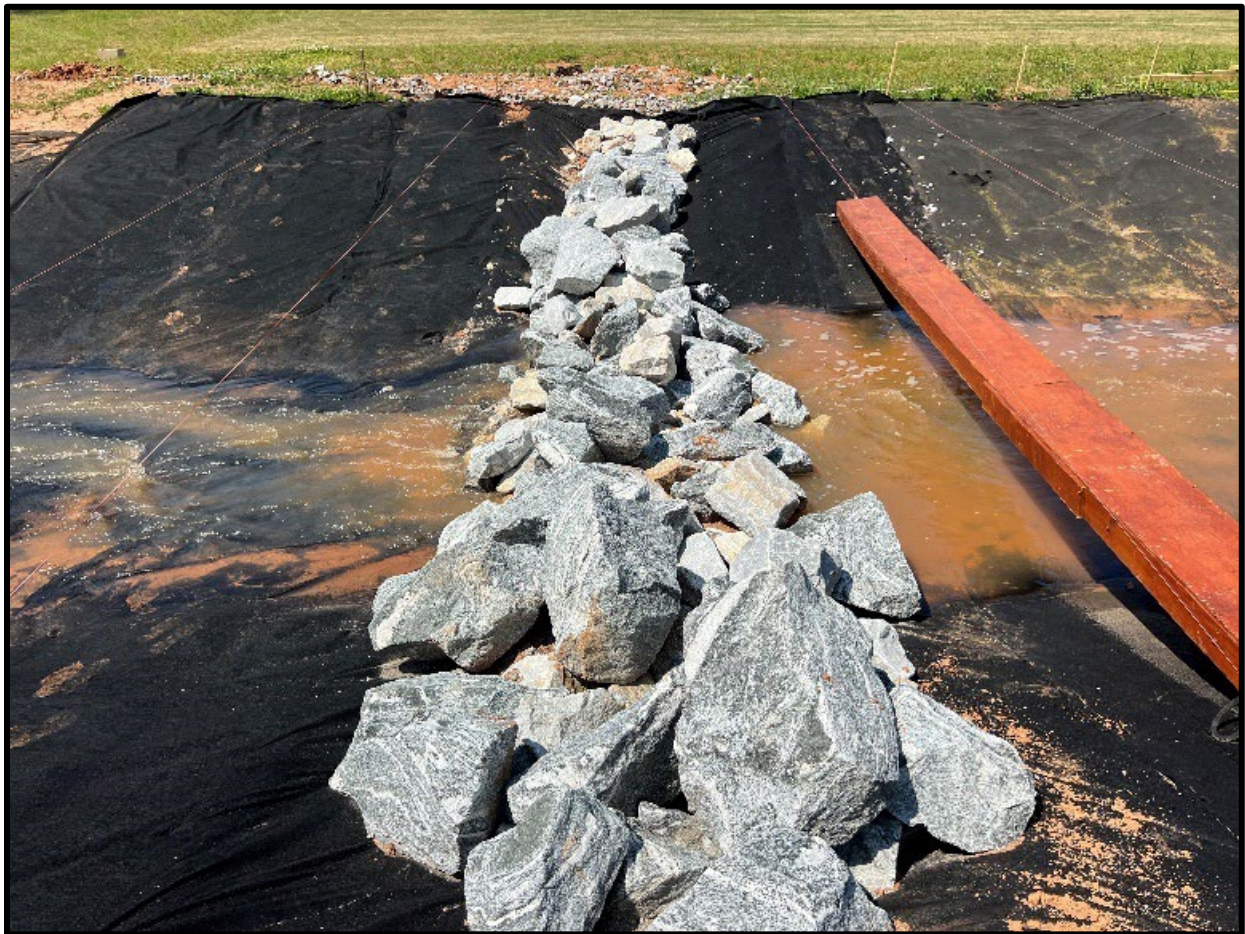
Figure 4.1: Upstream Impoundment of Iowa DOT Standard Installation

The standard Iowa DOT installation, under both the low and high flow rates, only slowed flow immediately upstream of the installation. An impoundment length of 4.2 ft (1.3 m) and 5.9 ft (1.8 m) was facilitated for the 0.85 and 1.70 ft³/s (0.024 and 0.048 m³/s) flow rates, respectively, indicating that only 7% and 9% of the channel was protected from erosive flows. Additionally, a maximum impoundment depth of 0.62 ft (0.19 m) was facilitated immediately upstream of the rock check dam, indicating much of the material in the installation was not playing a role in slowing flow. Only one cross-section upstream of the installation had subcritical flows during testing of both flow rates, further indicating much of the channel was subject to erosive flows. The performance of the Iowa DOT standard installation under clean-water conditions can be shown in Figure 4.1.

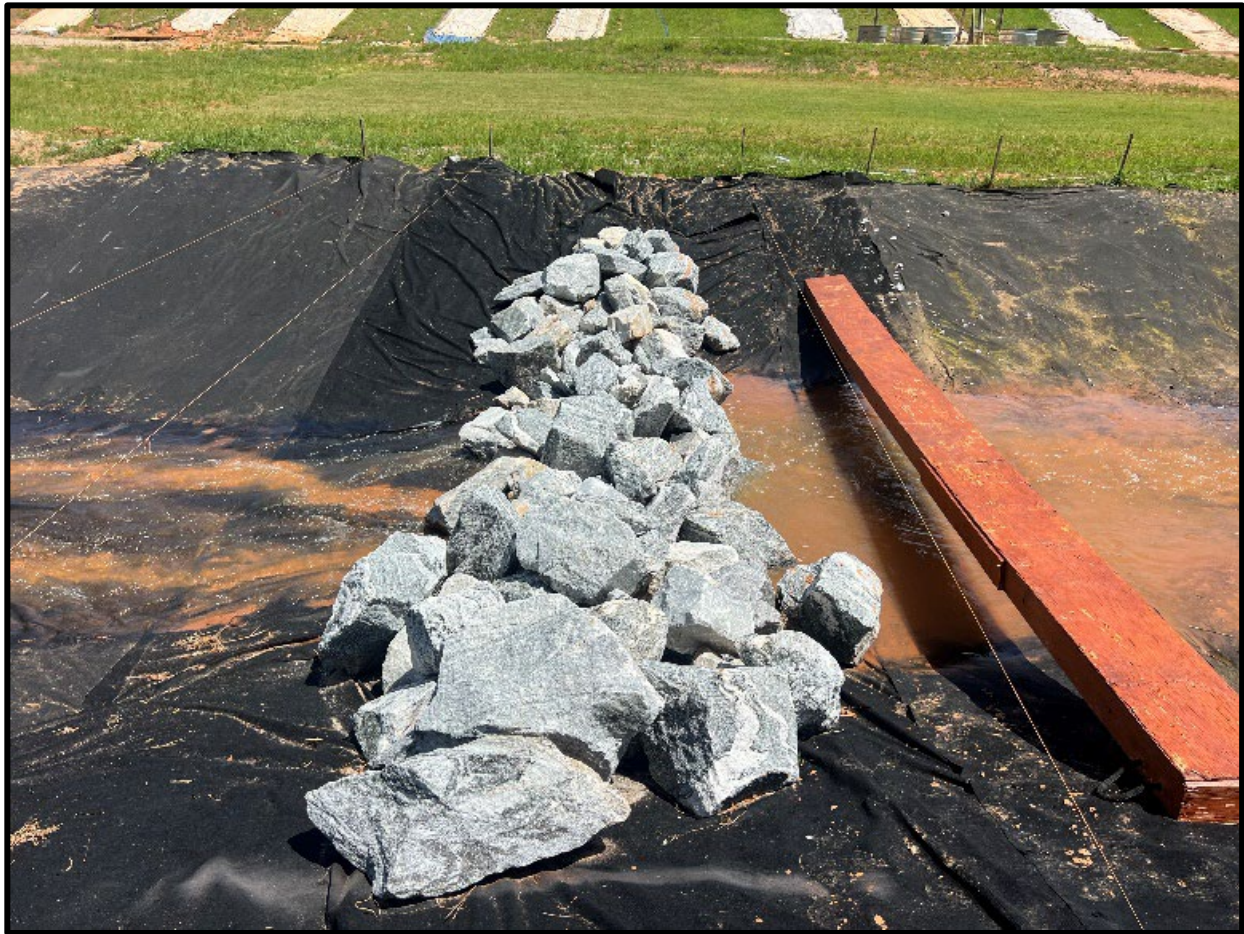
Figure 4.2: Upstream Impoundment of M1

M1 was developed to determine if the excavation beneath the standard installation impacted the installation's performance. Average impoundment lengths of 5.3 ft (1.6 m) and 8.1 ft (2.5 m) were facilitated for the low and high flow rate tests, respectively, as shown in Figure 4.2. A maximum impoundment depth of 0.68 ft (0.21 m) was formed upstream of the installation. When compared to the Iowa DOT standard installation, a statistically significant difference was not found at a 99% confidence level between impoundment lengths and depths across each set of testing and flow

rates, indicating that a loss or gain of performance was not shown through installing the rock check dam on grade rather than in the 6 in. (15.2 cm) excavation. Removal of this excavation would save installation and material costs for Iowa DOT rock check dams.

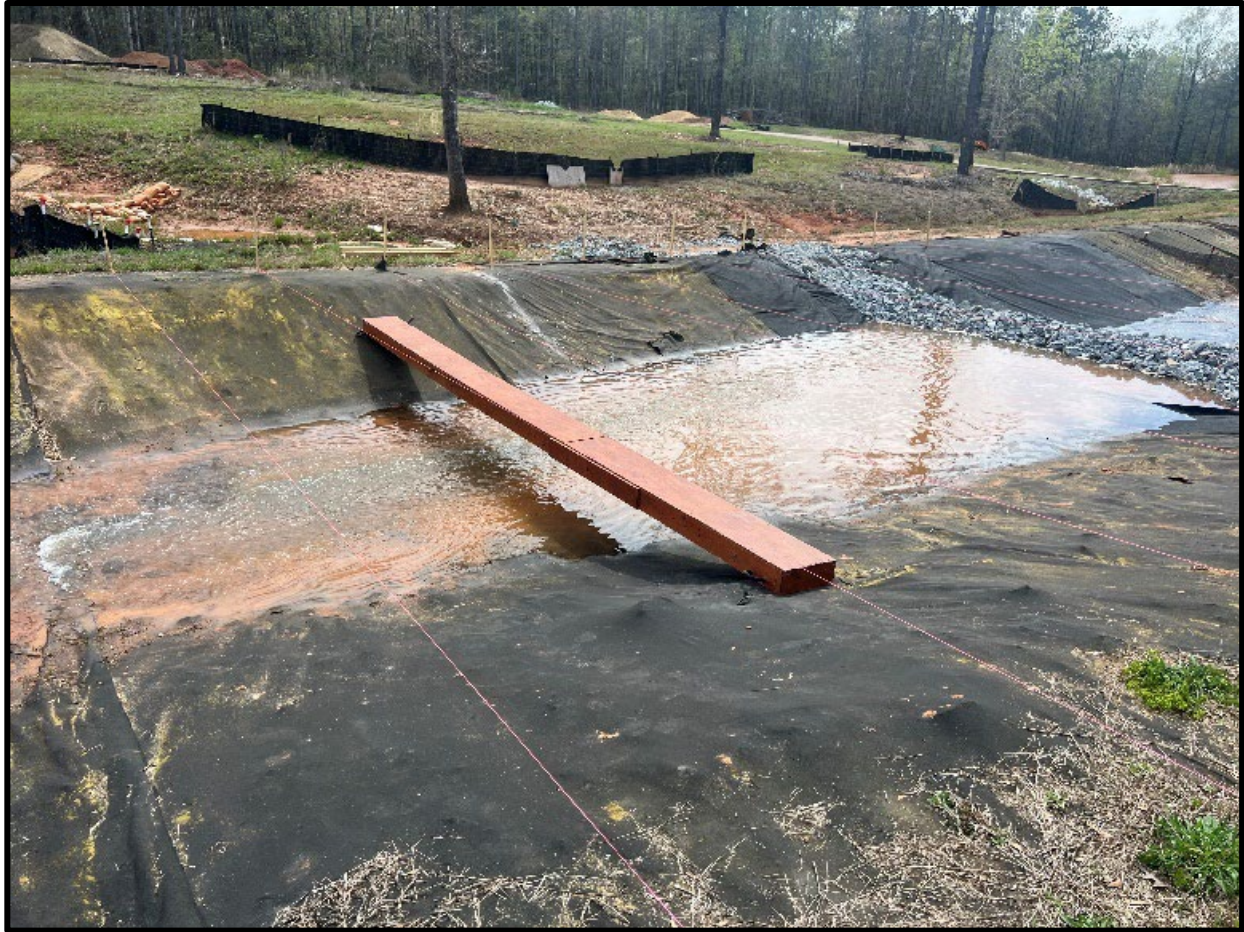
Figure 4.3: Upstream Impoundment of M2

The results of testing for both the standard installation and M1 indicated little flow velocity reduction capabilities due to large voids between rocks. To improve performance, a smaller rock gradation, also used by the Iowa DOT in other applications, was used for M2; this rock gradation, referred to as erosion stone, had a nominal size of 6 in. (15.2 cm) and was between 3 and 9 in. (7.6 and 22.9 cm). This smaller rock gradation, installed in an identical configuration to the Iowa DOT standard, facilitated increased impoundment length and depth compared to both installations that used the larger Class D revetment. As shown in Figure 4.3, impoundment lengths of 21.6 ft (6.58 m) and 32.7 ft (9.97 m) were facilitated for the low and high flow rates, respectively. Additionally, the average flow velocity for the smaller rock gradation installation was significantly lower than the average downstream velocity from the installations using the same rock as the Iowa DOT standard at a 95% confidence level; however, the average downstream velocities of 2.4 and 2.8 ft/sec (0.73 and 0.85 m/sec) for the low and high flow rate testing still exceed the permissible velocities for most soil types (*Massachusetts Department of Environmental Protection 2003*).

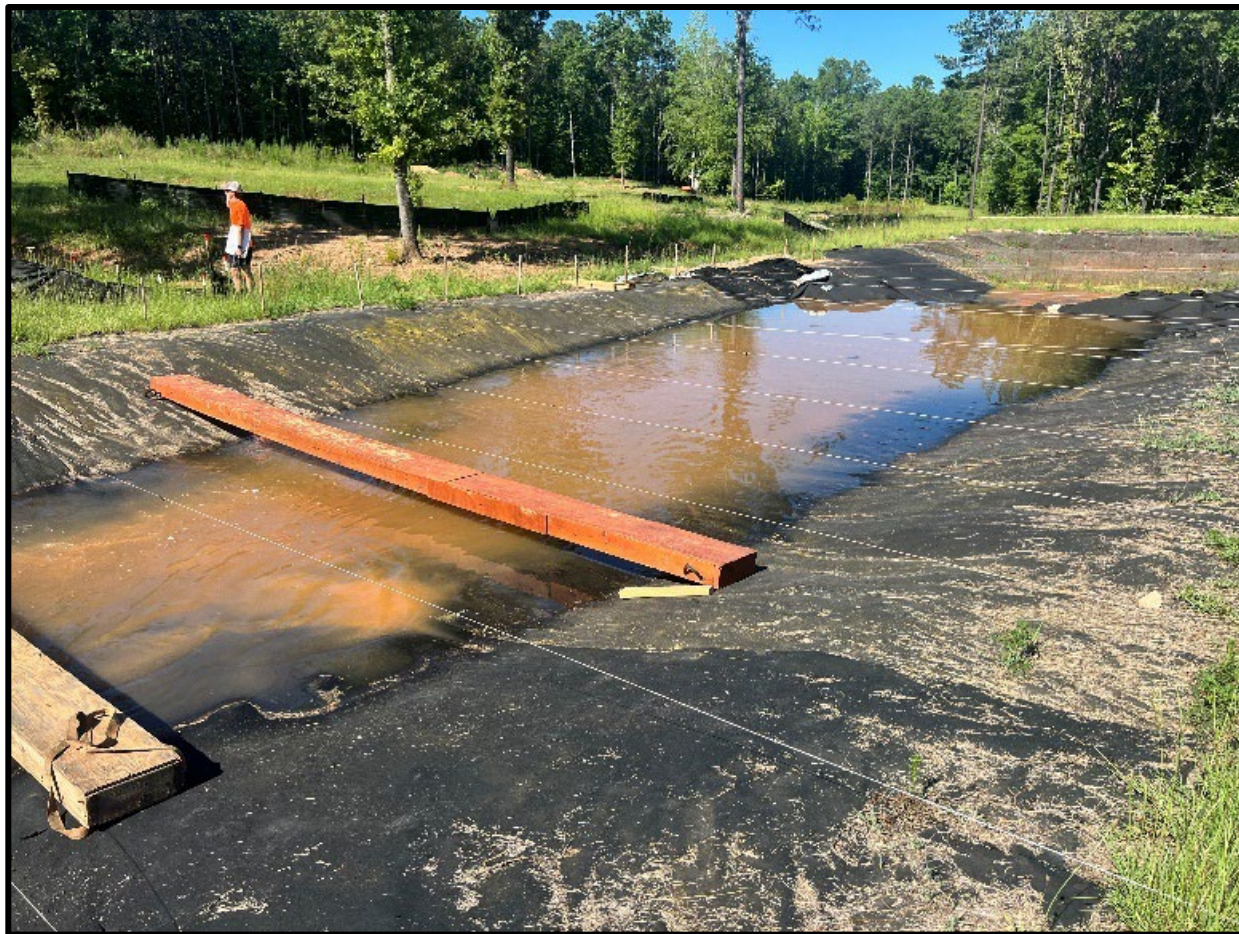
Figure 4.4: Upstream Impoundment of M3

The smaller rock gradation and decreased pore size improved performance compared to the standard installation with the larger rock gradation; however, highly erosive flow velocities were still present for more than half of the channel indicating that additional performance improvements needed to be made to fully protect channels from erosion. Past performance evaluations of rock check dams have shown that adding a geotextile overlay improves performance through the formation of additional impoundment. M3 was developed using the Iowa DOT standard rock gradation with a non-woven geotextile secured with 6 in. (15.2 cm) sod staples 2 ft (0.6 m) upstream of the dam, draped over the front face of the installed and secured on the back side of the installation with loose rock. M3, due to the addition of the geotextile, increased impoundment length to 49.3 ft (15 m) and 48.4 ft (14.8 m) on average for the low and high flow rates, respectively. For the low flow testing, impoundment length increased during each subsequent test as the geotextile became clogged with the low amounts of sediment from the supply pond; the third simulated storm event had an impoundment length of 62.5 ft (19.1 m). A similar pattern was shown for impoundment depth, with the first simulated storm event having the lowest depth and increasing for each subsequent test for the low flow rate. Additionally, for all but the first simulated storm event, the higher testing flow rate had a lower impoundment length than the low flow rates, with all tests having between 47.5 and 49.1 ft (14.5 and 15 m). The improved performance of M3 is shown in Figure 4.4.

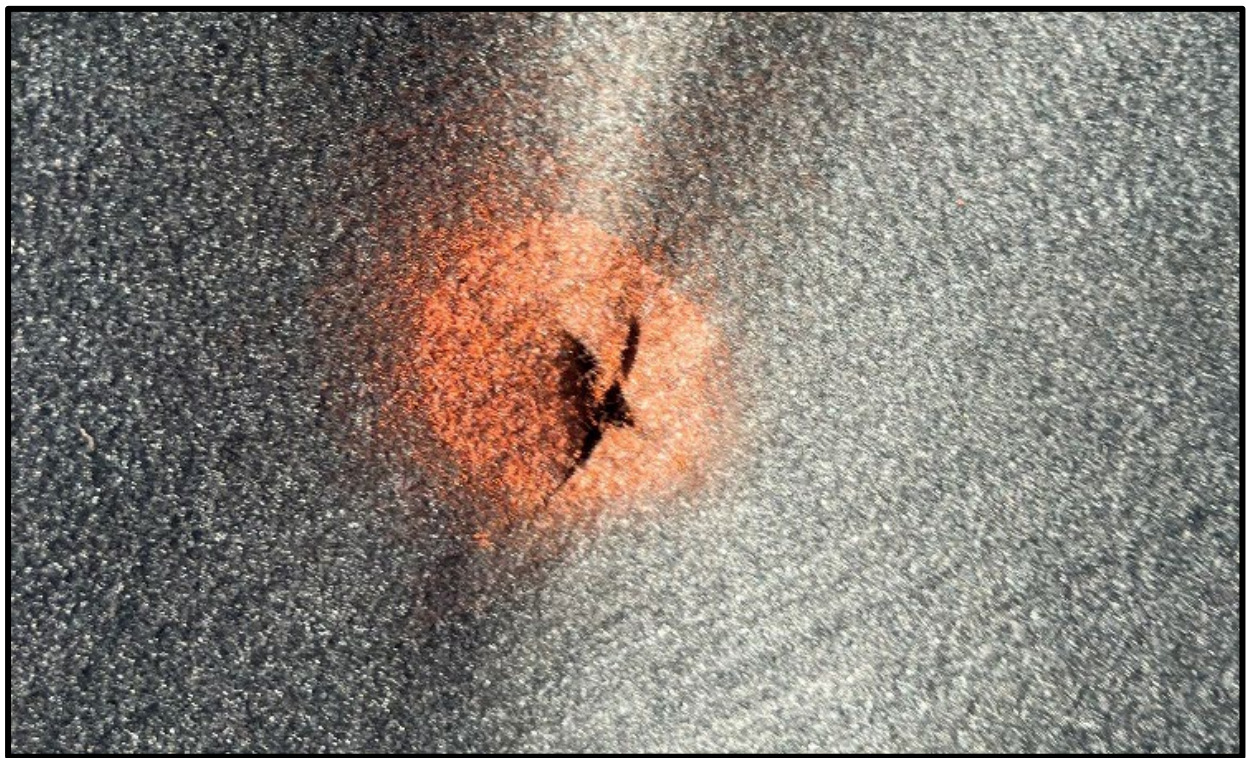
Figure 4.5: Dewatering Holes

(a) dewatering hole locations

(b) dewatering hole

During testing of M3, high dewatering times, exceeding 72 hours, were experienced as the geotextile became clogged with sediment. For testing of all subsequent installations, dewatering times were monitored using a Solinist™ levellogger. To reduce dewatering times, M4 was developed, which included three sets of dewatering holes spaced 1 ft (0.3 m) vertically up the front face of the installation at the center of the channel and at the toes of the side slopes, 5 ft (1.5 m) apart. The dewatering holes are shown in Figure 4.5.

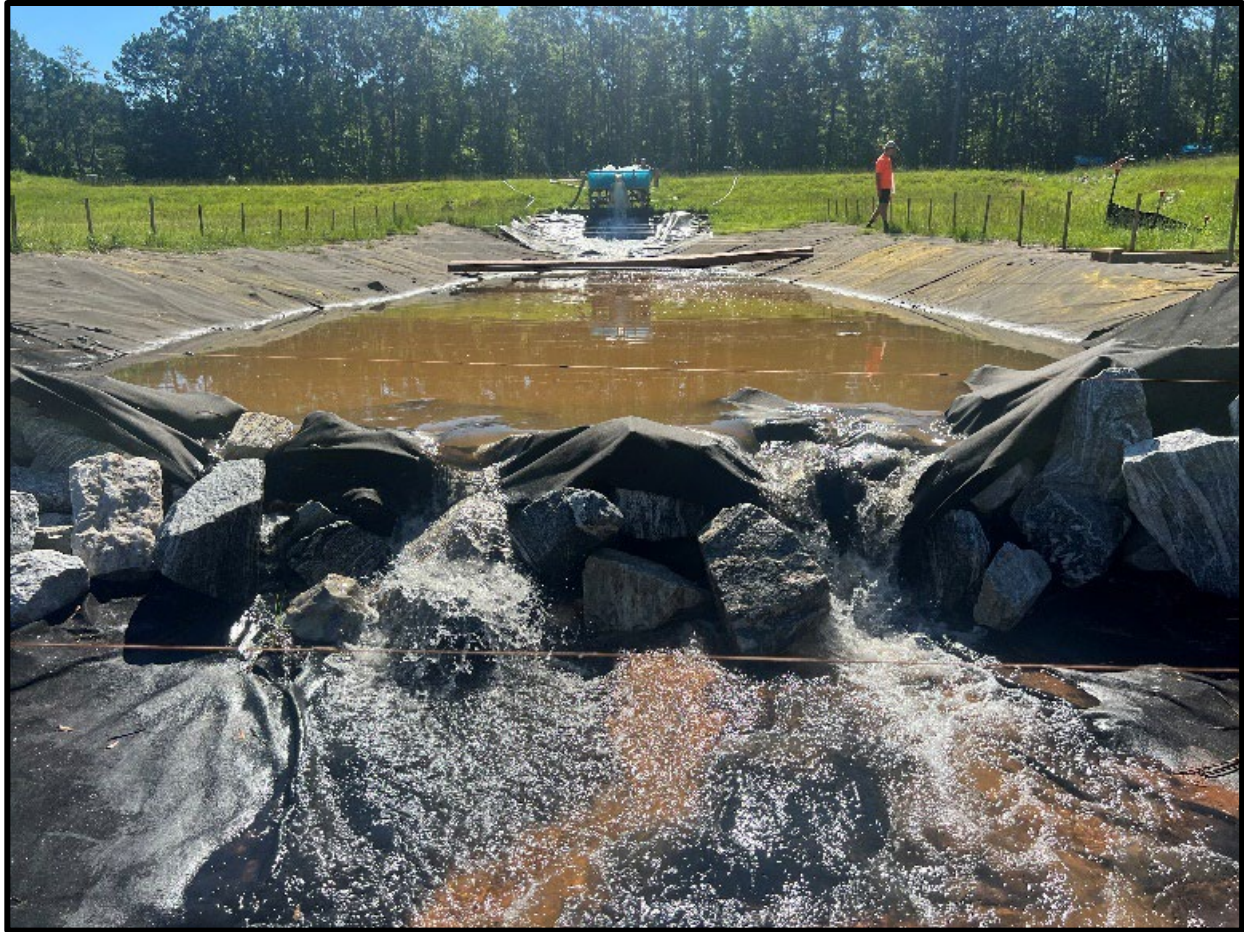
Figure 4.6: Flow Overtopping at Lowest Point Between Large Rocks of M3

Despite the improvements made to rock check dam installations through the addition of a geotextile overlay, impoundment heights failed to reach the 2 ft (0.6 m) height stipulated in the specifications. Flow was able to overtop at the lowest point, which was often a gap between rocks, as shown in Figure 4.6; additionally, the geotextile would form around the large, often jagged rocks, increasing the risk of tearing. To combat this, M5 was developed, which was an identical installation to M3 (no excavation and with a geotextile overlay) but with the Iowa DOT erosion stone rather than the Class D Revetment. The smaller gradation rock had the goal of more consistent and reliable installation height, while also providing increased performance compared to the larger rock in the event of the geotextile failing.

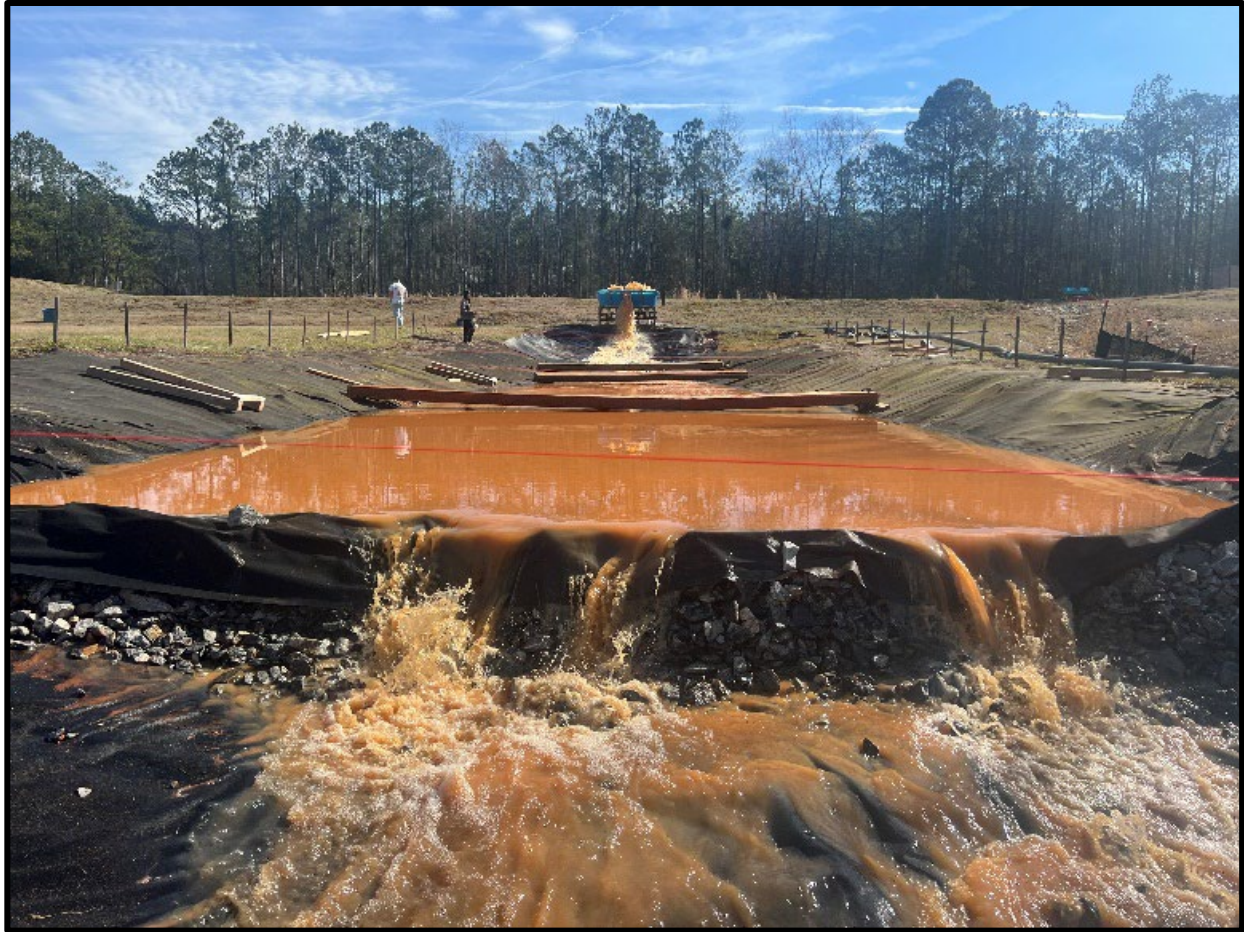
Figure 4.7: M5 overtopping

M5 showed similar results to both installations with geotextile overlay that employed the larger rock gradation with average impoundment lengths of 52.5 ft (16 m) and 56.8 ft (17.3 m) for the low and high flow rate testing, respectively, while also overtopping at a more consistent water depth as shown in Figure 4.7. An additional installation, M6, was evaluated that used the geotextile overlay and dewatering holes over an installation with smaller rock; M6 facilitated average impoundments of 49.9 ft (15.2 m) and 55.3 ft (16.9 m) for the low and high flow rates, respectively. The impoundment facilitated by M5 and M6 did not have a statistically significant difference. The installations using the smaller rock with the geotextile overlays (M5 and M6) had a statistically significantly greater impoundment length than the two evaluated installations with the larger Class D Revetment (M3 and M4) under testing of the higher flow rate due to the more consistent height and reduced low points at the center of the installation.

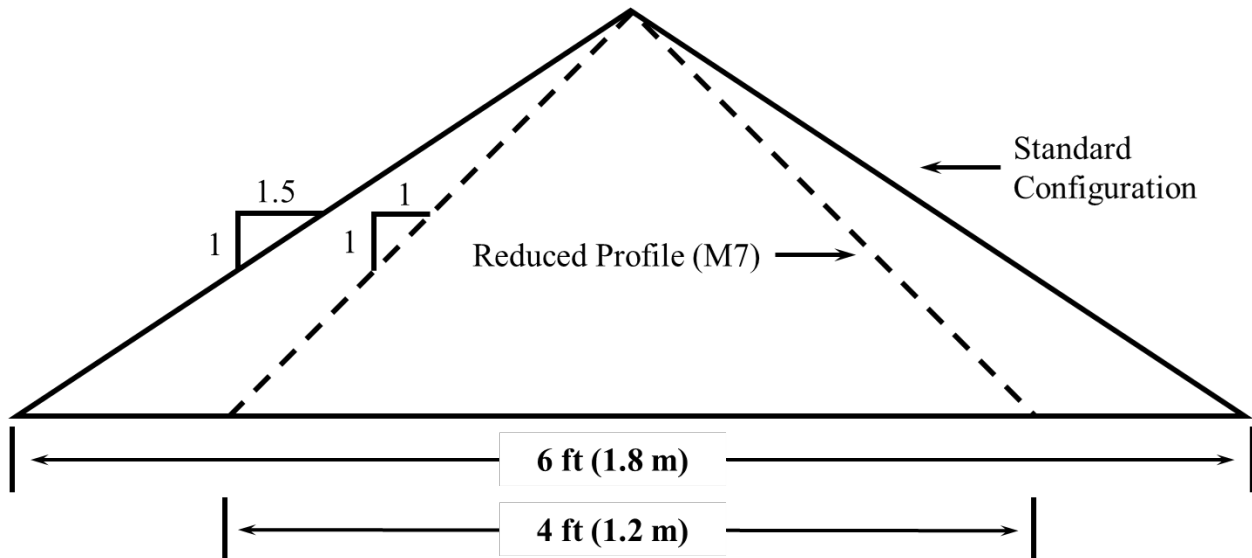
Figure 4.9: Cross-section of M7 and standard configuration

To further reduce the cost of material and installation, M7 was developed, which was identical to M6 but with steeper side slopes to reduce the bottom width of the installation from 6 ft (1.8 m) to 4 ft (1.2 m), considerably reducing material used per installation; a cross-section view of M7 and the standard configuration used by all other evaluated rock check dams is shown in Figure 4.9. Impoundment levels facilitated by the reduced profile installation were similar to those by other installations with geotextile overlays, with an average of 58.7 ft and 57.5 ft (17.9 and 17.5 m) facilitated for the low and high flow rates, respectively. Additionally, little visible washout was experienced by the installation through the three simulated stormwater runoff events.

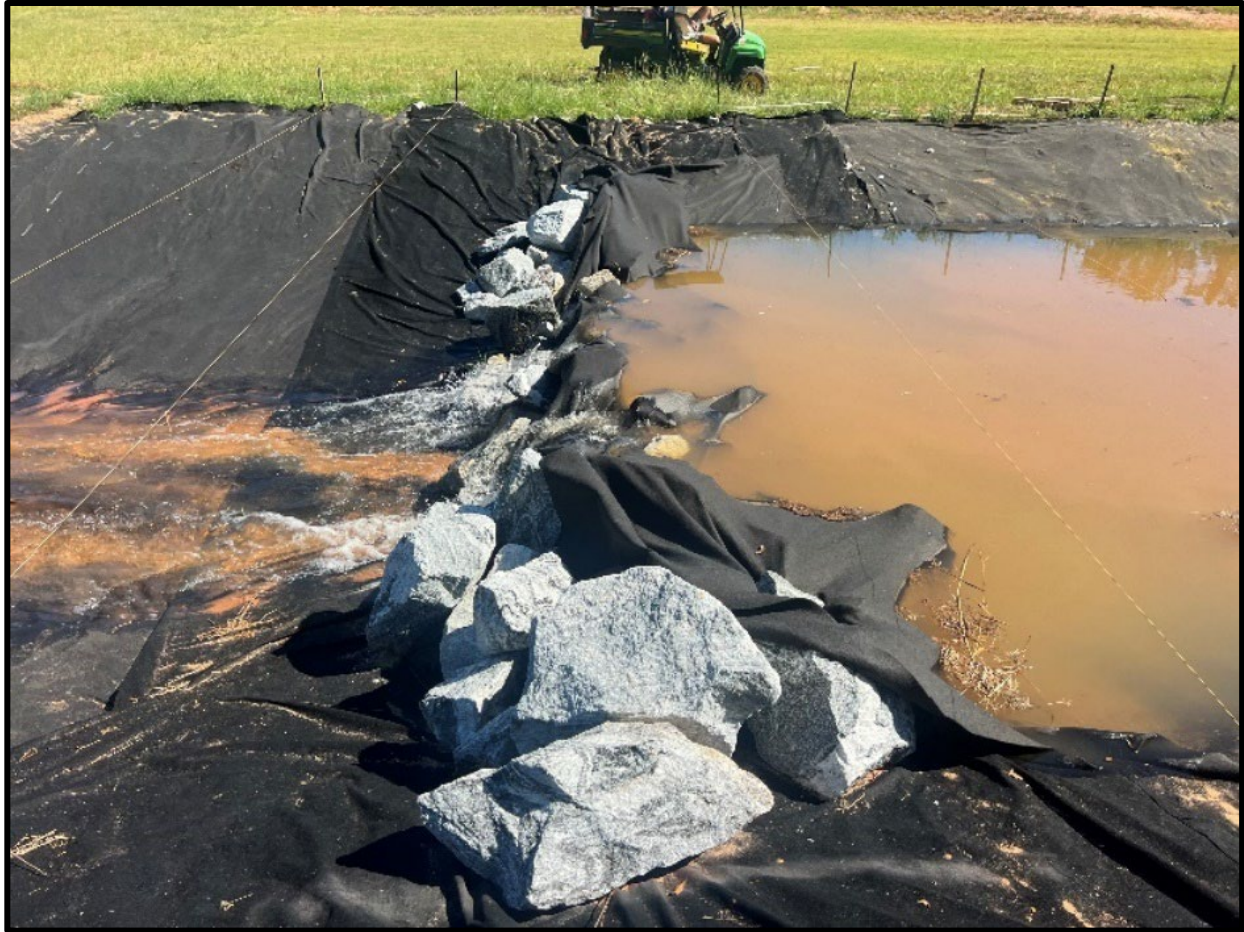
Figure 4.12: High Flow Velocities Downstream of Overtopped Installation

Downstream of all rock check dam installations, flow velocities increased to erosive levels, indicating downstream protection is required to ensure erosion does not occur, as shown in Figure 4.10. Additionally, for high-flow testing, the average velocity for rock check dam installation in areas where impoundment was formed was still above permissible velocities for highly erodible soils, indicating additional protection is required for channels with erosive soils where high flows are expected.

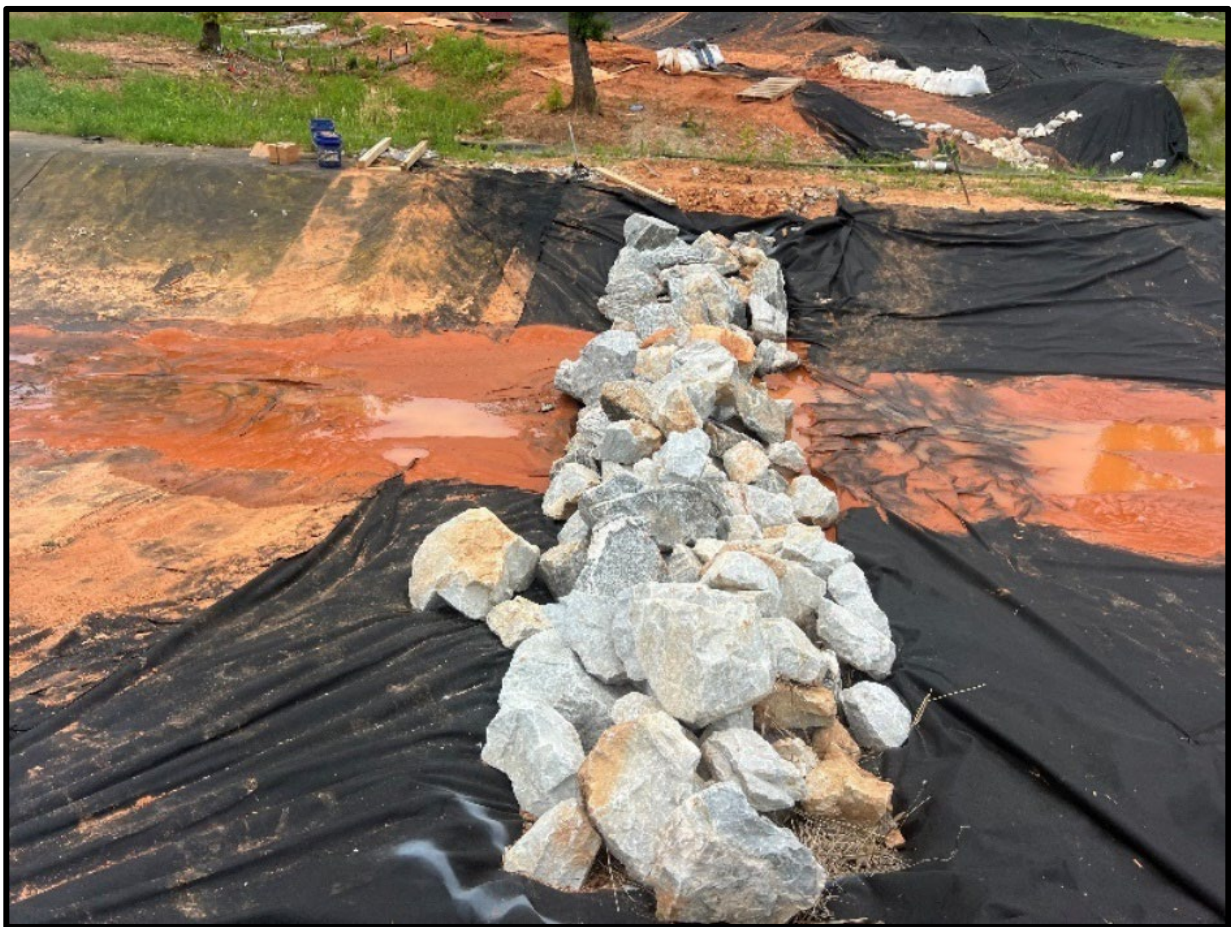
Figure 4.13: Sediment Deposition Upstream of Iowa DOT Standard Installation

Due to the low impoundment levels formed by the Iowa DOT standard installation, little sediment deposition occurred. The sediment deposited was immediately upstream of the rock check dam, with little to no sediment able to fall out of suspension anywhere else in the channel due to high flow velocities, as shown in Figure 4.12. Deposited sediment was removed, weighed, and evaluated for moisture content to compare the dry weight of deposited sediment to the dry weight of introduced sediment to determine overall sediment capture. After three sediment-laden stormwater runoff events, only 9.4% of introduced sediment was deposited upstream of the rock check.

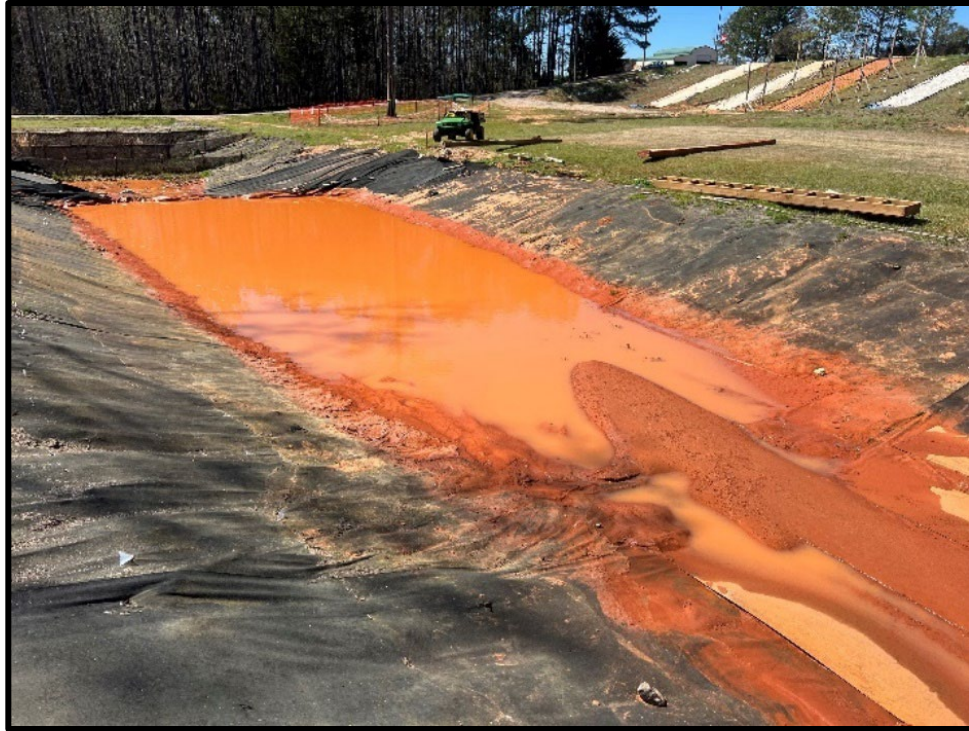
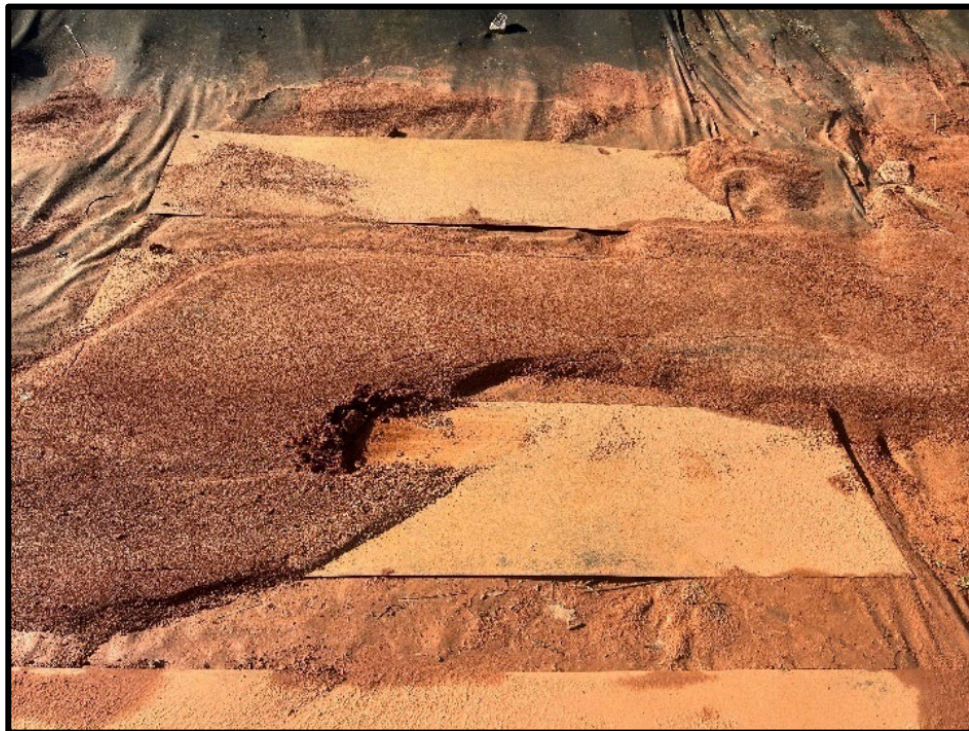
Figure 4.14: MFE-I Sediment Deposition.

(a) upstream sediment deposition

(b) coarse material deposited

Due to the additional impoundment formed by the MFE-I during sediment-laden evaluations, increased sediment was deposited in the impoundment formed by the installation. 72.4% of the introduced sediment was captured upstream of the installation. A large portion of this sediment was captured immediately after the hydraulic jump, as shown in Figure 4.13a; the sediment that was deposited further upstream was visibly coarser than the sediment captured immediately upstream of the rock check dam installation, as shown in Figure 4.13b.
