NCAT Report 96-03

A STUDY OF LONGITUDINAL JOINT CONSTRUCTION TECHNIQUES IN HMA PAVEMENTS (INTERIM REPORT - COLORADO PROJECT)

February 1996

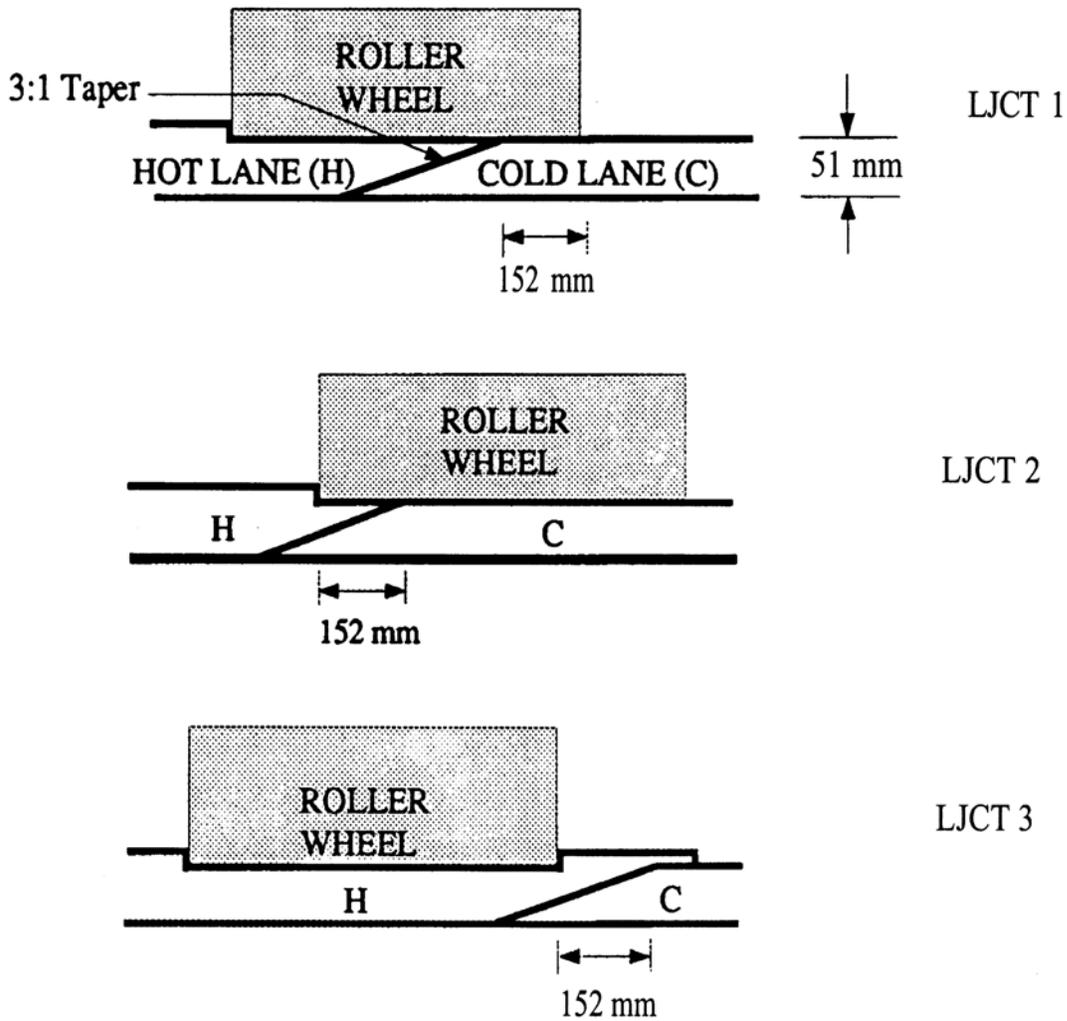
Figure 1. Joint Construction and Rolling Techniques LJCT 1 through LJCT 3 (Colorado Project)

The unconfined edge of the first paved lane was constructed with a 3:1 taper at the proposed joint. Normally, a steel plate is rigidly attached to the screed to give the desired taper. However, on this project a piece of steel plate was dragged by chain behind the screed. The resulting taper was not as smooth as would be obtained with a plate rigidly attached to the screed. The taper was then tacked with a diluted slow-setting emulsified asphalt (50% emulsion + 50% water), and a conventional overlapping technique was used to place the hot side material on the following day. The end gate of the paver extended about 25 to 38 mm (1 to 1.5 inch) over the top surface of the previously placed material. The height of the uncompacted material above the previously placed material was about 6 mm (1/4 in.) for each 25 mm (1 inch) of compacted material placed. No luting was done. The joint was compacted from the hot side, overlapping the cold side of the joint approximately 152 mm (6 in.). This type of compaction, in which the major portion of the roller weight travels on the hot side, is believed to result into a good bond between the cold and hot sides of the joint (5, 6). The compaction technique is shown in Figure 1.

The only difference between this method and LJCT 1 is that the rolling was done with a major portion of the roller wheel on the cold side with about 152 mm (6 in.) of the roller wheel on the hot side of the joint. This technique is believed to produce a “pinching” effect on the joint. However, timing in this type of rolling is critical. When the roller is operated on the cold side, the hot side undergoes cooling which can make it difficult to achieve the desired compaction level. The method is shown in Figure 1.

Compaction in this method was started with the edge of the roller about 152 mm (6 in.) from the joint on the hot side (Figure 1). Other than that, this method is similar to LJCT 1. The lateral pushing of the material toward the joint during the first pass of the roller is believed to produce a high density at the joint. This method is particularly recommended by some asphalt paving technologists for tender mix or thick lifts, which have the potential for the mix to be pushed towards the joint.

Among the three rolling techniques (LJCT 1, LJCT 2, and LJCT 3) attempted with a 3:1 taper on this project, rolling from the hot side (LJCT 1) gave the lowest density at the joint. This is unlike

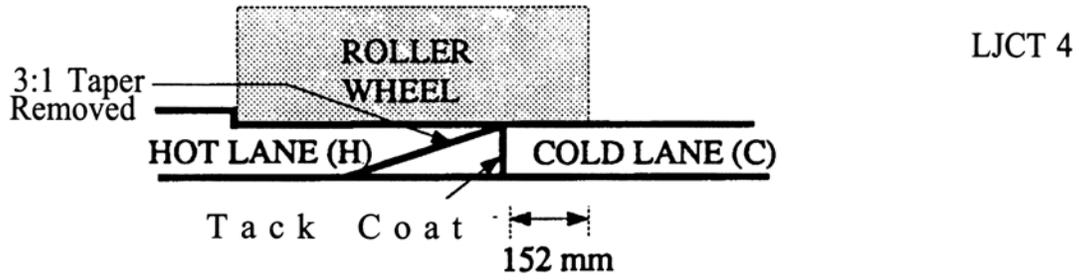
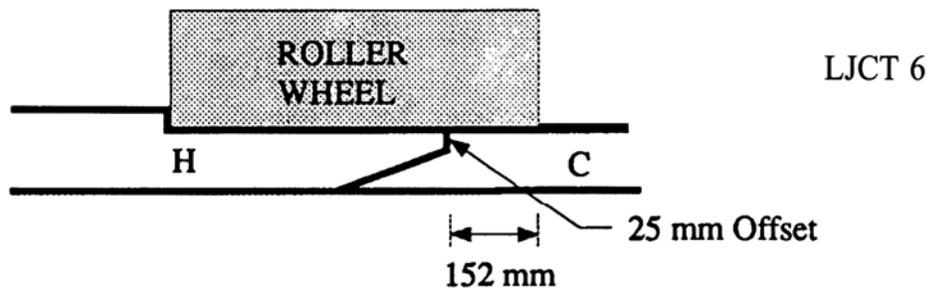
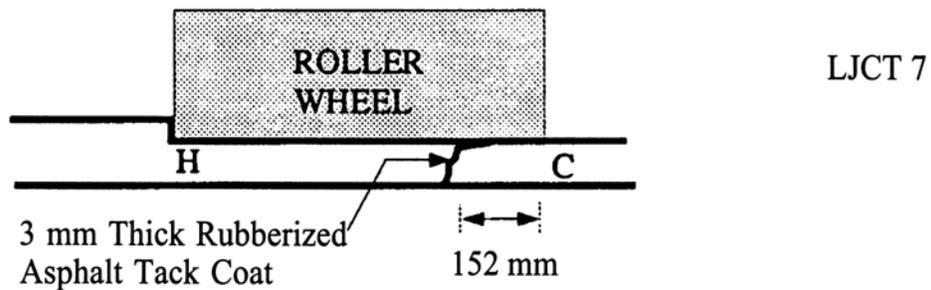
Figure 2. Joint Construction and Rolling Techniques LJCT 4 through LJCT 7 (Colorado Project)

In this method (Figure 2), the cold side unconfined edge was constructed with a 3:1 taper. Then the full width of the taper was removed on the following day with a cutting wheel attached to a motor grader. Since the material had cooled, the cutting was done very carefully, avoiding any disturbance to the lower lifts. The hot side material was then placed after applying a tack coat on the vertical face of the cut. Laydown and compaction were achieved as indicated in LJCT 1, that is, rolling of the joint was accomplished from the hot side. Initially, cutting could not be done in a straight line because the operator of the motor grader did not have experience in this operation. Later, a straight line cut was obtained.

SAME AS ABOVE EXCEPT NO TACK COAT ON VERTICAL CUT FACE LJCT 5

This type of joint was constructed in the same way as LJCT 4 except that no tack coat was applied to the vertical face before placement of the adjacent hot lane.

In this method, the cold side unconfined edge was constructed with a 25.4 mm (1 in.) vertical step (offset) at the top of the joint. The remainder of the joint was constructed with a 3:1 taper (Figure 2). The vertical face was not tacked, but the taper surface was tacked, before placement of adjacent hot material and subsequent rolling according to the method of LJCT 1 (rolling from hot side). The vertical step (offset) was formed by placing a 610 mm (2 feet) long piece of 51 mm x 51 mm (2 in. x 2 in.) angle iron under the drag device used to form the 3:1 taper. There was some pulling of the larger particles of aggregate, but the overall vertical step face was satisfactory.

The unconfined edge of the first paved lane adjacent to the joint was not provided with any taper in this experimental section. On the following day, a rubberized asphalt tack coat (Crafco pavement joint adhesive Part Number 34524) was applied on the face of the unconfined edge before placing the adjacent lane. The thickness of the tack coat was about 3 mm (1/8 in.). Laydown and compaction of the adjacent lane were achieved following the procedures in LJCT 1 (rolling from hot side).

Overall, it appears that the technique LJCT 6 (which consisted of 25 mm (1 in.) offset and a 3:1 taper) appears to be the best in terms of density (Table 3). This is followed by LJCT 4 in which the 3:1 taper with relatively low density was removed by a cutting wheel. Similar results were also obtained in Michigan and Wisconsin experimental sections involving the use of cutting wheel (4).

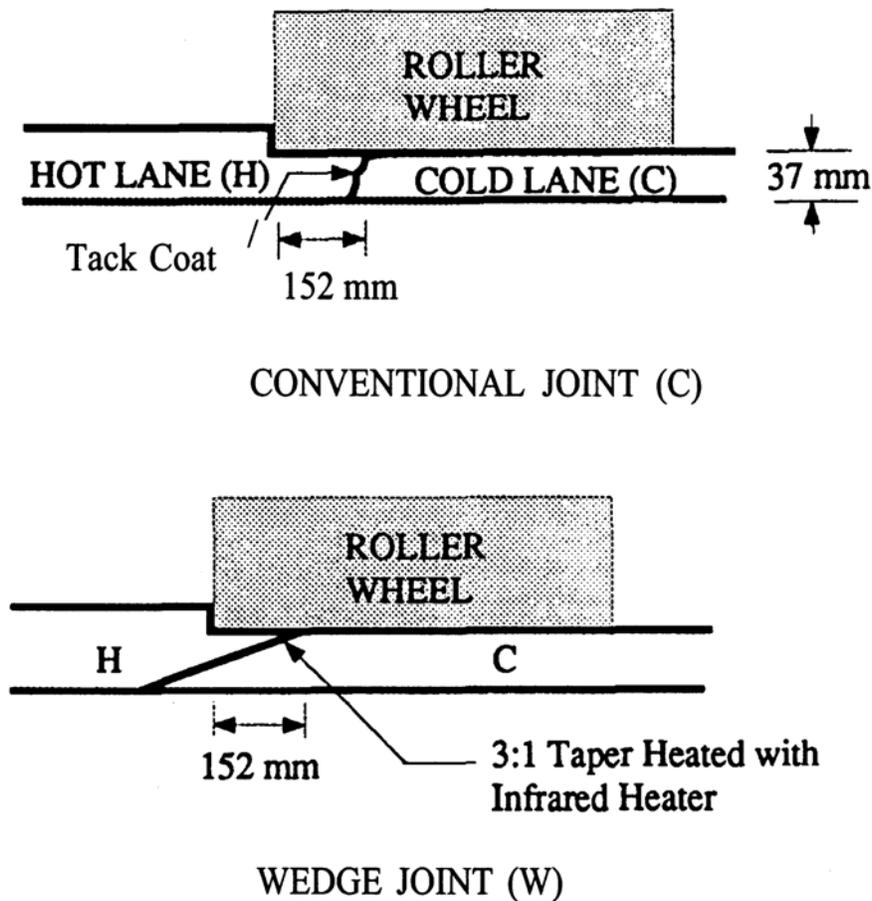
Figure 3. Joint Construction and Rolling Techniques (Pennsylvania Project)

The unconfined edge of the first paved lane did not receive any taper and, therefore, had its natural slope. The edge was tacked with an AC-20 asphalt cement. A conventional overlapping technique was used to place the mix in the adjacent lane which was placed after about a week.

The end gate of the paver extended about 76 to 102 mm (3 to 4 in.) over the top surface of the previously compacted lane. Luting was done to bump back the coarse aggregate particles of the HMA mix from the cold (first paved) lane onto the edge of the hot lane. The joint was compacted from the cold side, overlapping the hot side of the joint approximately 152 mm (6 in.), using the breakdown roller in static mode.

The longitudinal wedge joint consists of two overlapping wedges. A sloping steel plate was attached to the inside corner of the paver screed extension to form a 3:1 taper on the unconfined edge of the first paved lane. The inclined face of the taper was neither compacted nor tack coated. An infrared heater attached to the paver was used to heat the face of the taper when the adjacent mat was placed after about a week. The heater was turned off whenever the paver was stopped. LPG Vapor fired convection type ribbon burners in the infrared heater had a total capacity of 522,000 BTU/hour and heated a surface area 381 mm x 1930 mm (15 in. x 76 in.). A surface temperature ranging from 121° to 138°C (250° to 280°F) was obtained on the taper face.

Overlapping, luting, and compaction techniques for the wedge joint were similar to those used for the conventional joint described earlier.

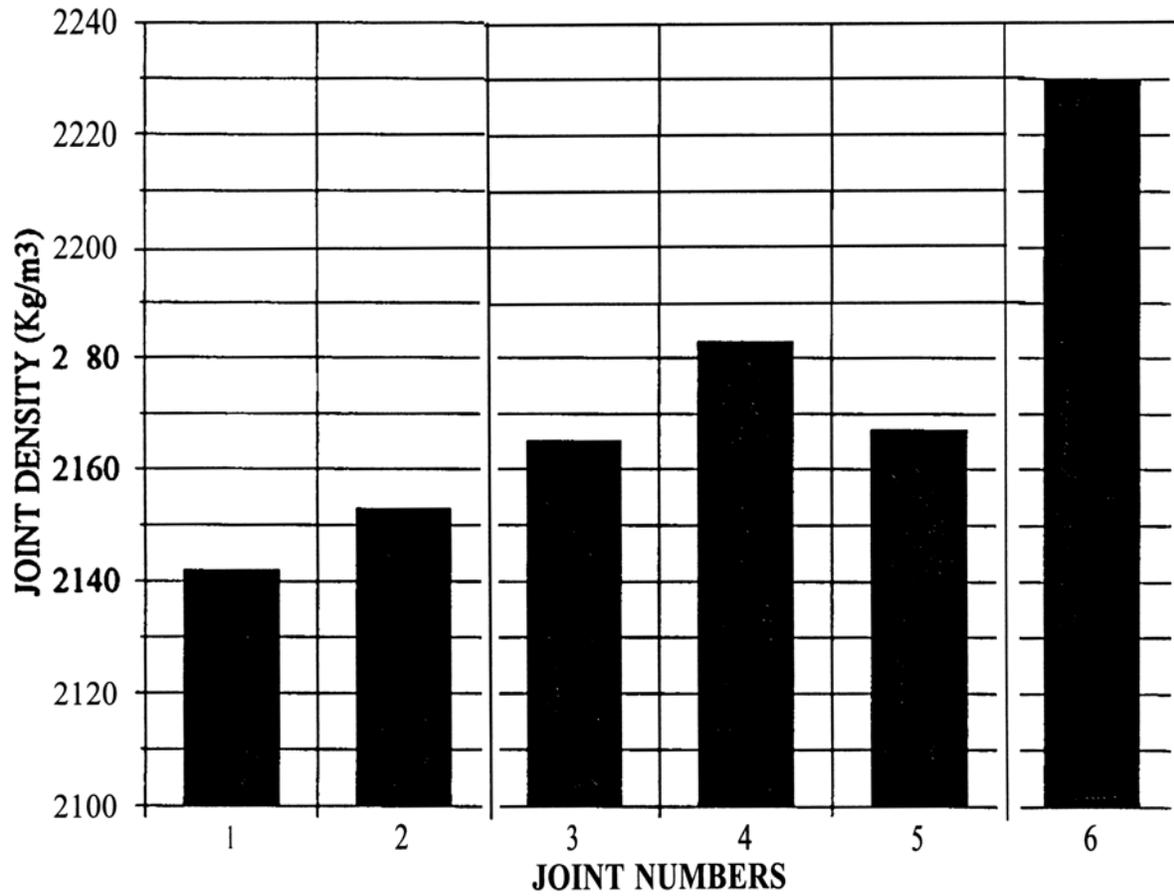
Figure 4. Comparison of Joint Densities (Colorado Project)

Table 2 shows the summary statistics for density and air voids of cores obtained from six different sections. No cores were obtained from Section LJCT 7 which used a rubberized asphalt tack coat. As expected, densities and air voids on the joint generally show higher standard deviation compared to those 305 mm (1 foot) away on either side of the joint. In all the sections, the joint density is observed to be lower than the cold and hot mat densities. Figure 4 compares the average joint density obtained in all sections.
