Sunshine Bridge Emergency Repair

ALABAMA TRANSPORTATION CONFERENCE

Chris B. Guidry, P.E.

LADOTD Asst. Bridge Design Administrator

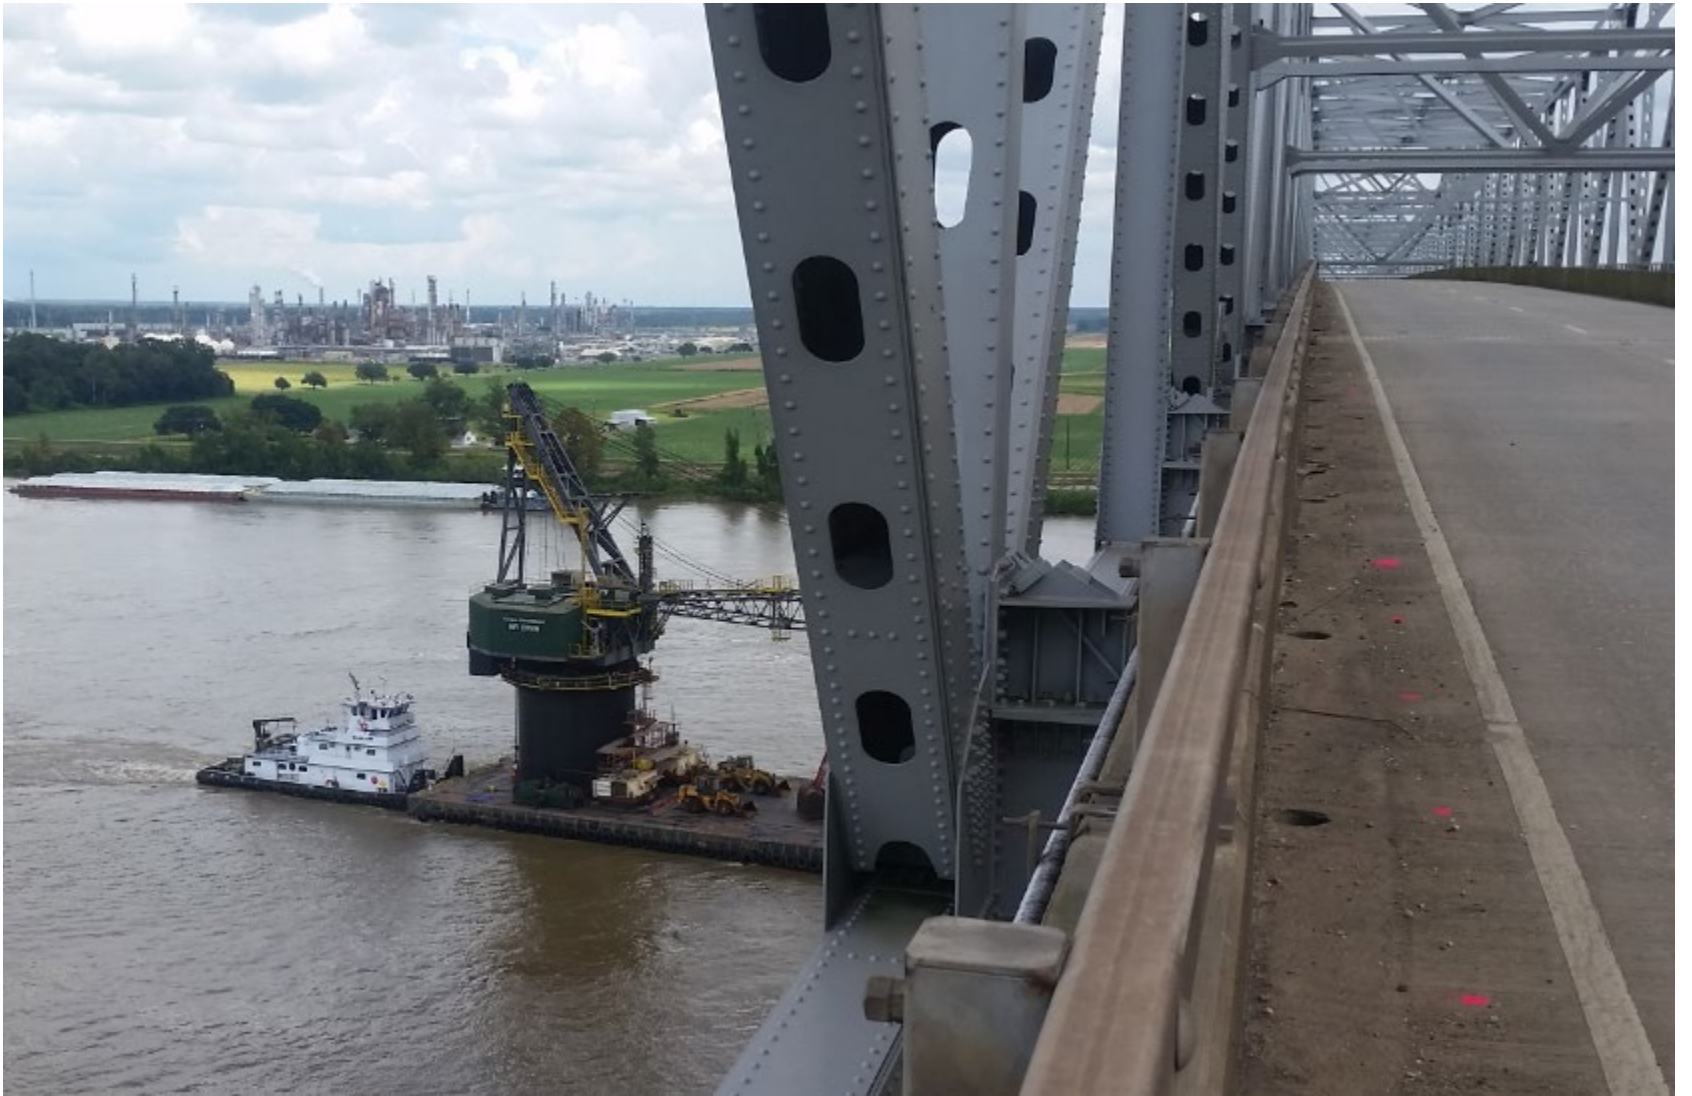
Damaged Bottom Chord L15 – L16
Compression Member
DL = 1.7 Million Pounds
(~142 Elephants)

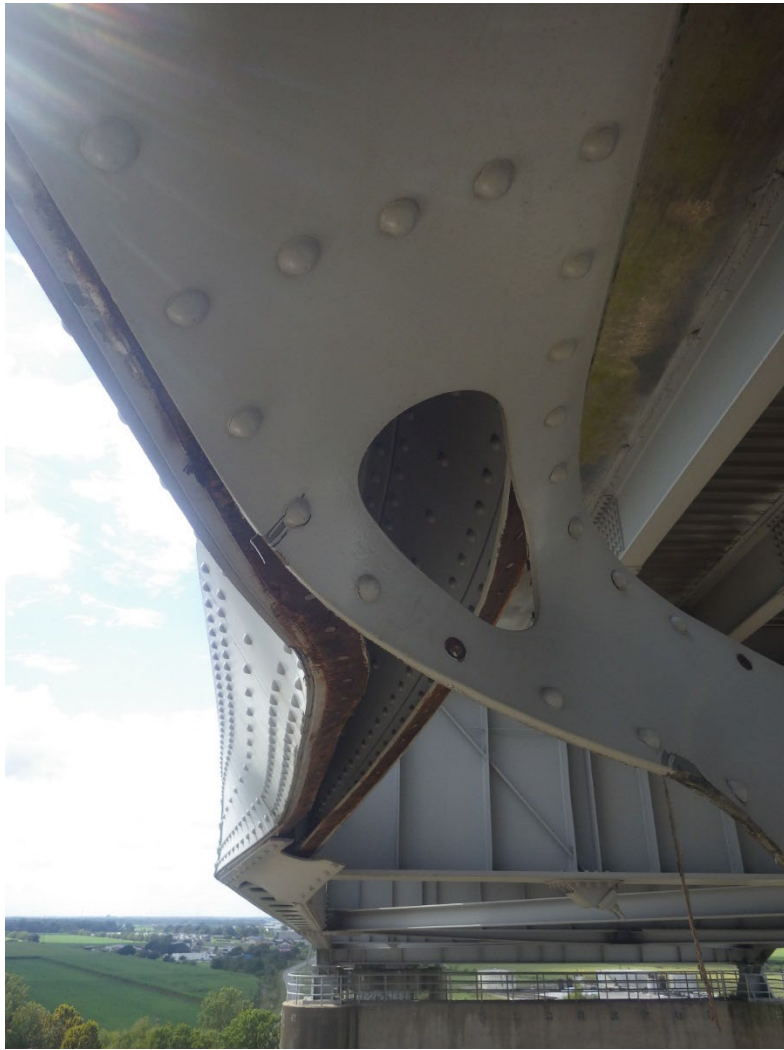
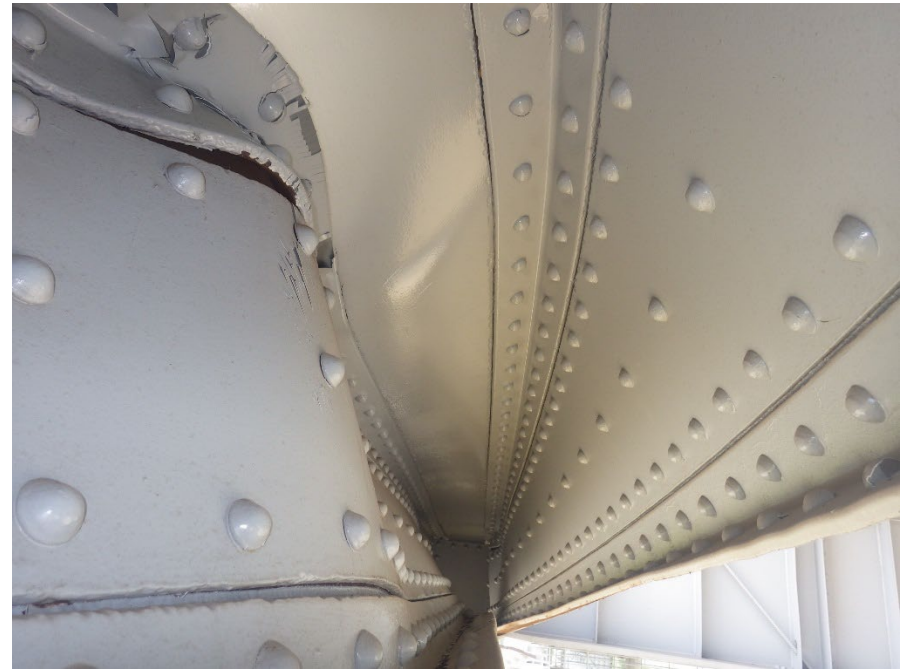
APPROXIMATELY 16"
LATERAL DEFLECTION

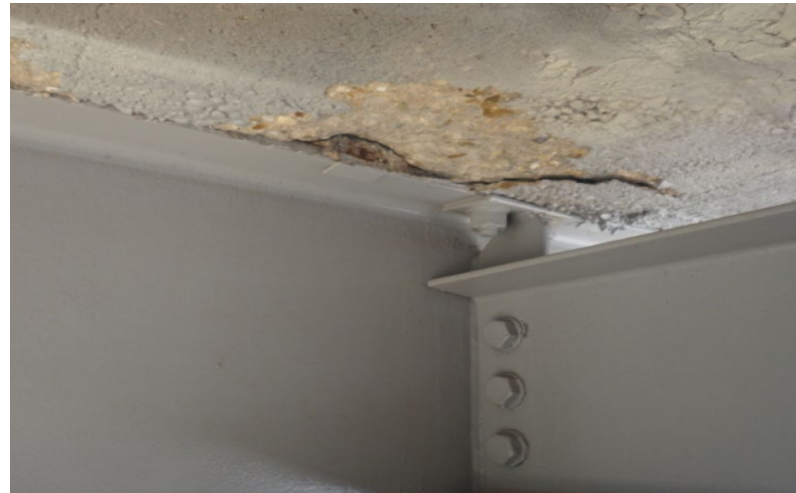
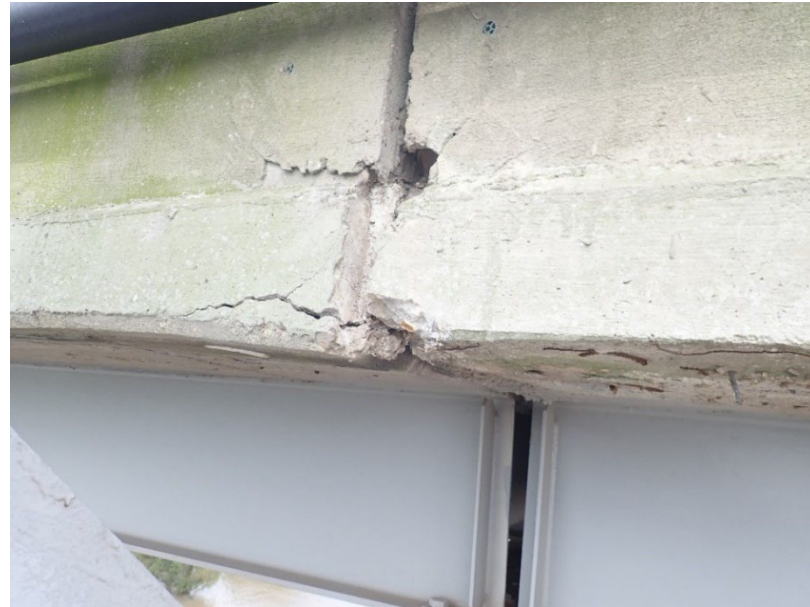
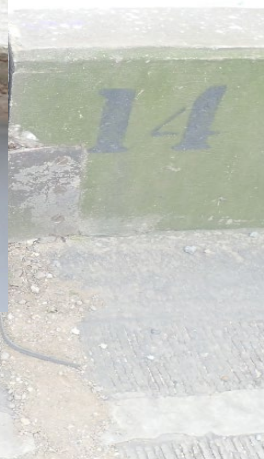
49 locations
160+ misc. damages

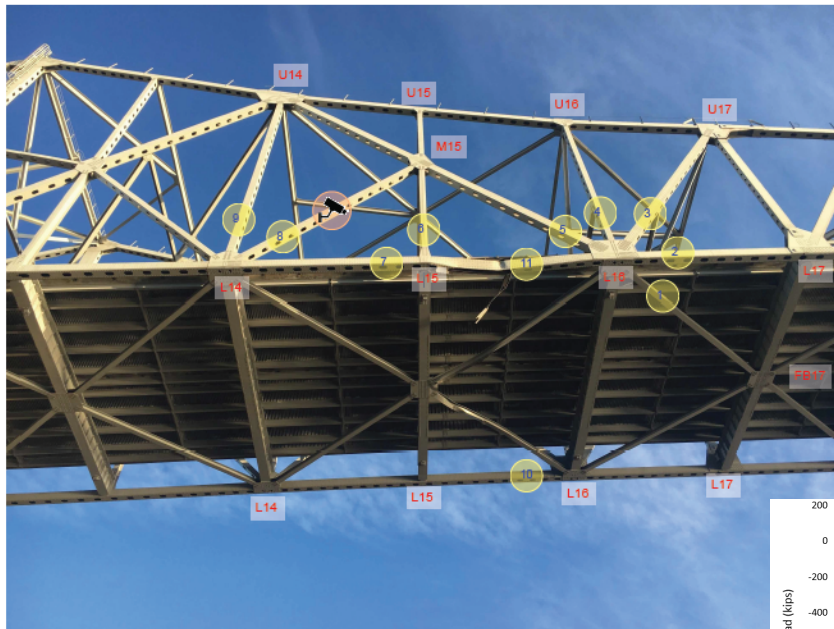
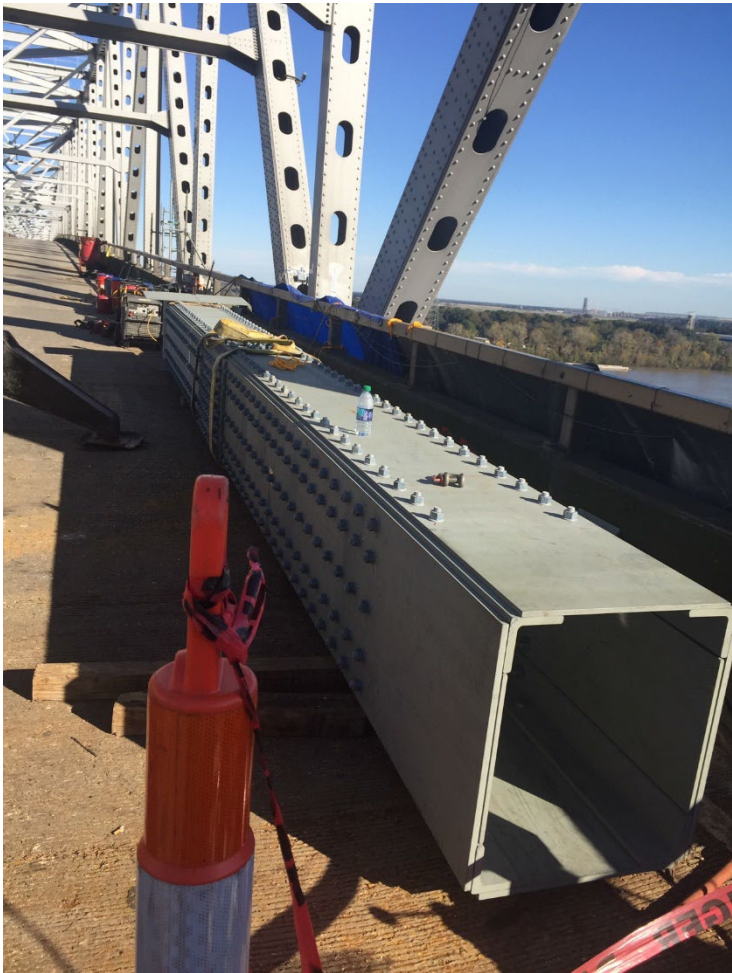
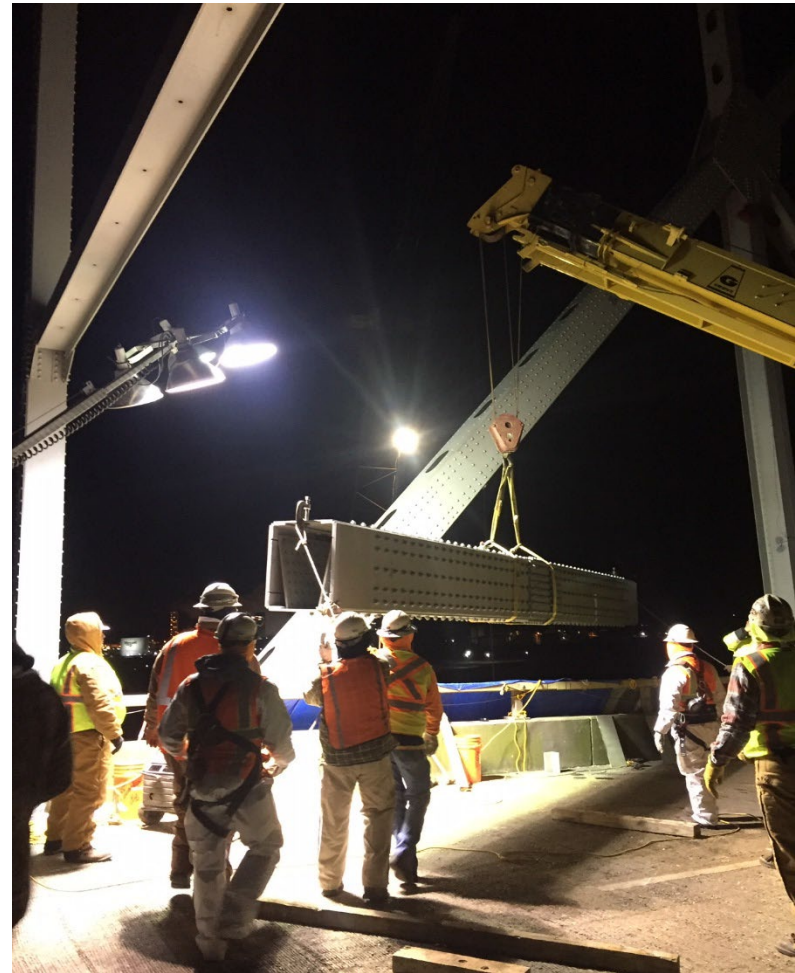
Jacking Monitoring System

Jacking Up to 2.1 Million Pounds at 50k increments. Critical, Slow, and Long Process 100+ Steps

Step 4 – Jacking Structure to Original Geometry

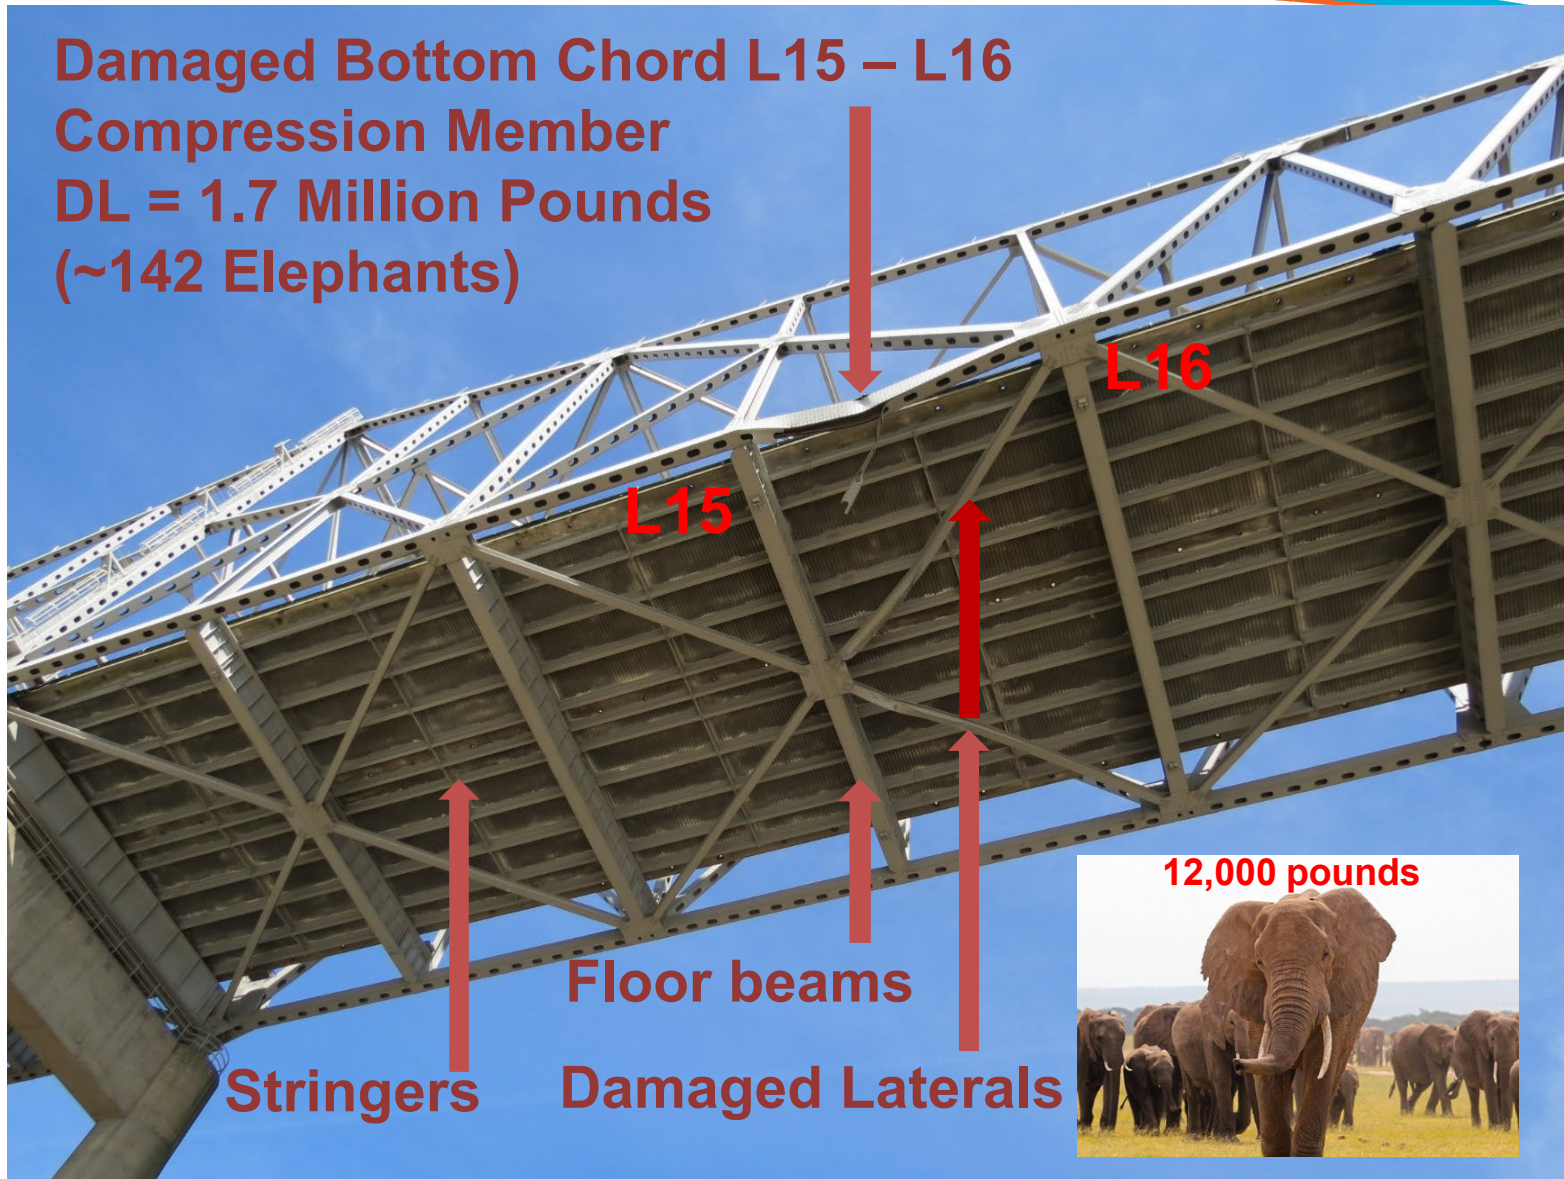
Damaged Bottom Chord L15 – L16
Compression Member
DL = 1.7 Million Pounds
(~142 Elephants)

Where did these elephants go after impact?
How many trapped in the damaged chord?
